Case No. 16UR004

**TKRS PROPERTIES**  
 11 NEW YORK STREET  
 RAPID CITY, SD

Revision / Date  
 Sheet Name  
**OVERALL FENCE LAYOUT**  
 Sheet Number  
**1 of 3**

On January 29, 2016, Senior Officer Ron Terviel and I (Senior Officer Robin Black) had the opportunity to do a Crime Prevention Through Environmental Design (CPTED) Inspection at Prairie Market and Time Square Plaza, 11 New York St. Prairie Market is a grocery store.

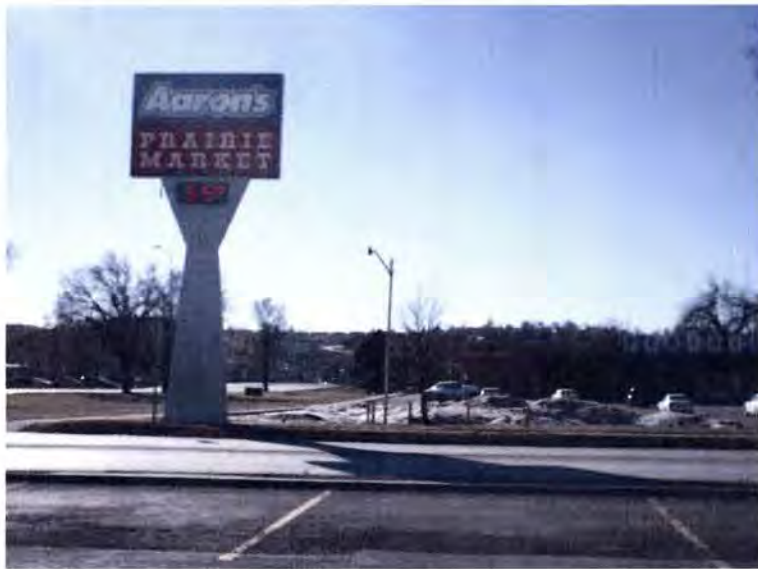
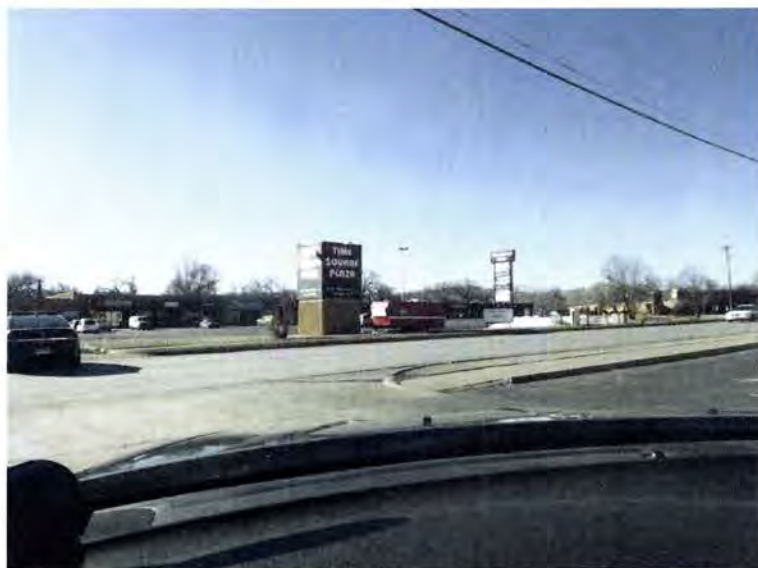
Starting at the north side (front) of Prairie Market, there were two signs entering the property. One sign was on the northeast side of the property, and one on the northwest of the property when entering the parking lot. This definitely let's people know, this property belongs to Prairie Market.

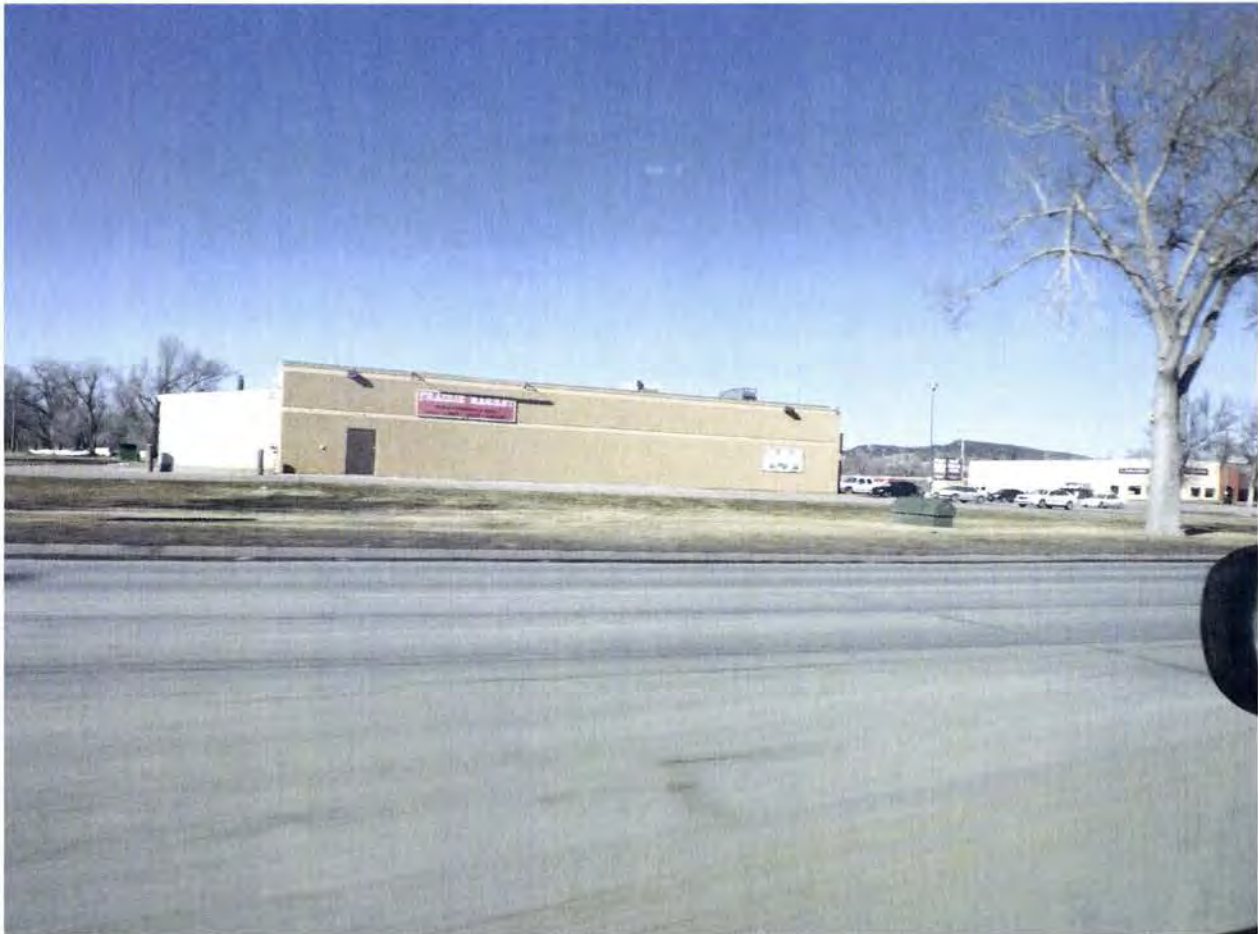
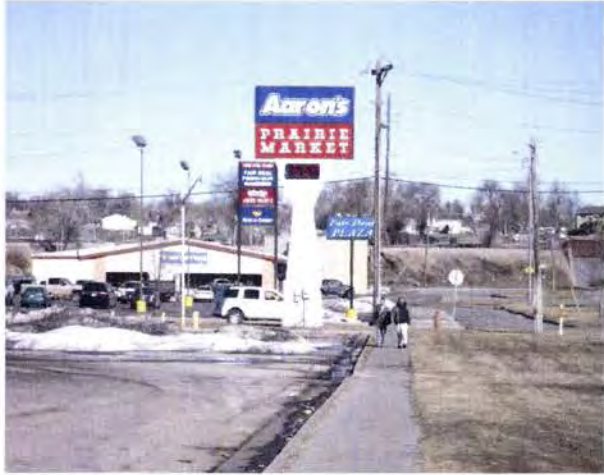
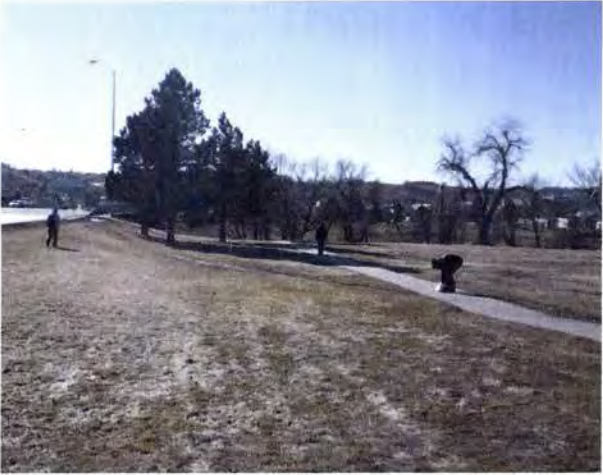
We went to the east side of the building, we observed the roadway leading to the south side (back) of the building had trash up against the building and also broken glass on the road. There was a door on the east side of the building, which was not accessible from the outside. There was a light above a sign on the east side of the building. I am not sure how much the light illuminates the outside of the building at night. This area had several empty alcohol containers and debris along the roadway and the building. There was also broken glass on the roadway.

This area has the most foot traffic to and from the bike path to Prairie Market. The foot traffic also comes from East Blvd from the north and south. As we took pictures, it shows several people walking through this area.

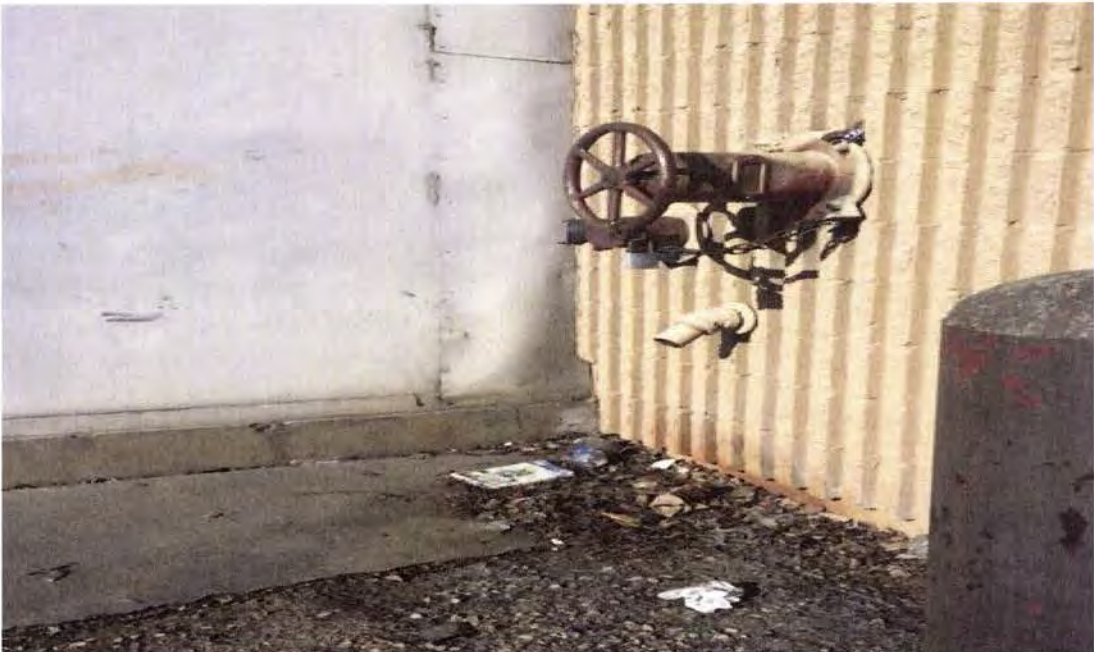
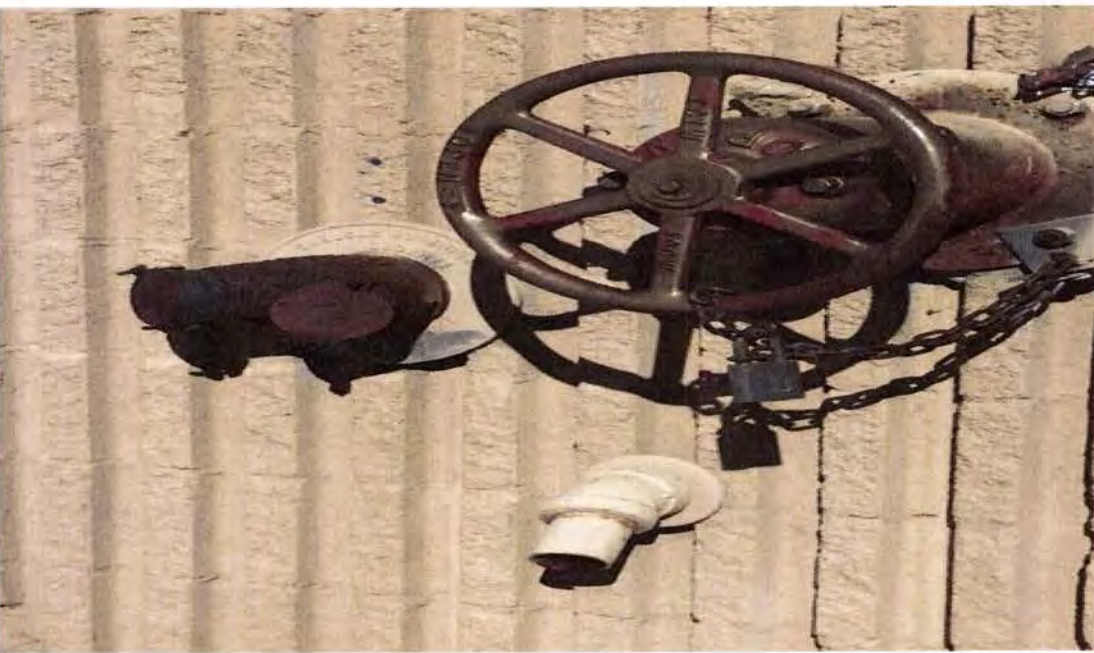
There was also a cove near the southeast side of the building which had an inlet for the business sprinkler system. This system was secured with a lock and chain. This also needs to be accessible to the fire department to attach to in the event of a fire. This area also had trash and debris.

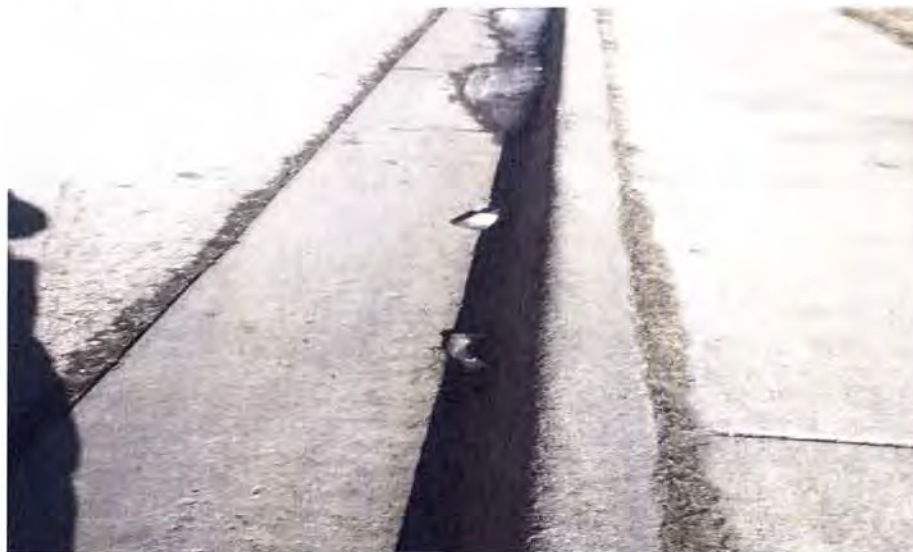
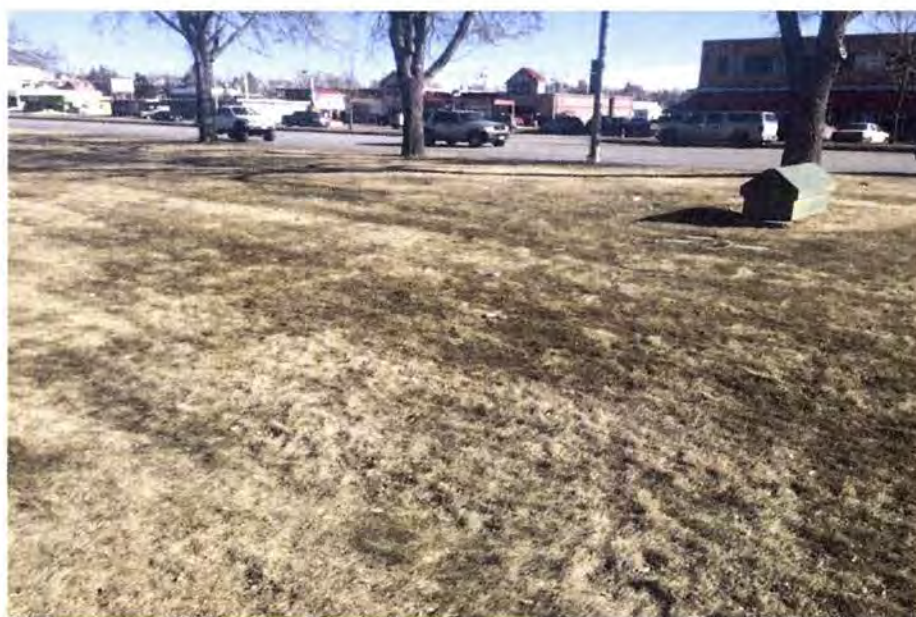
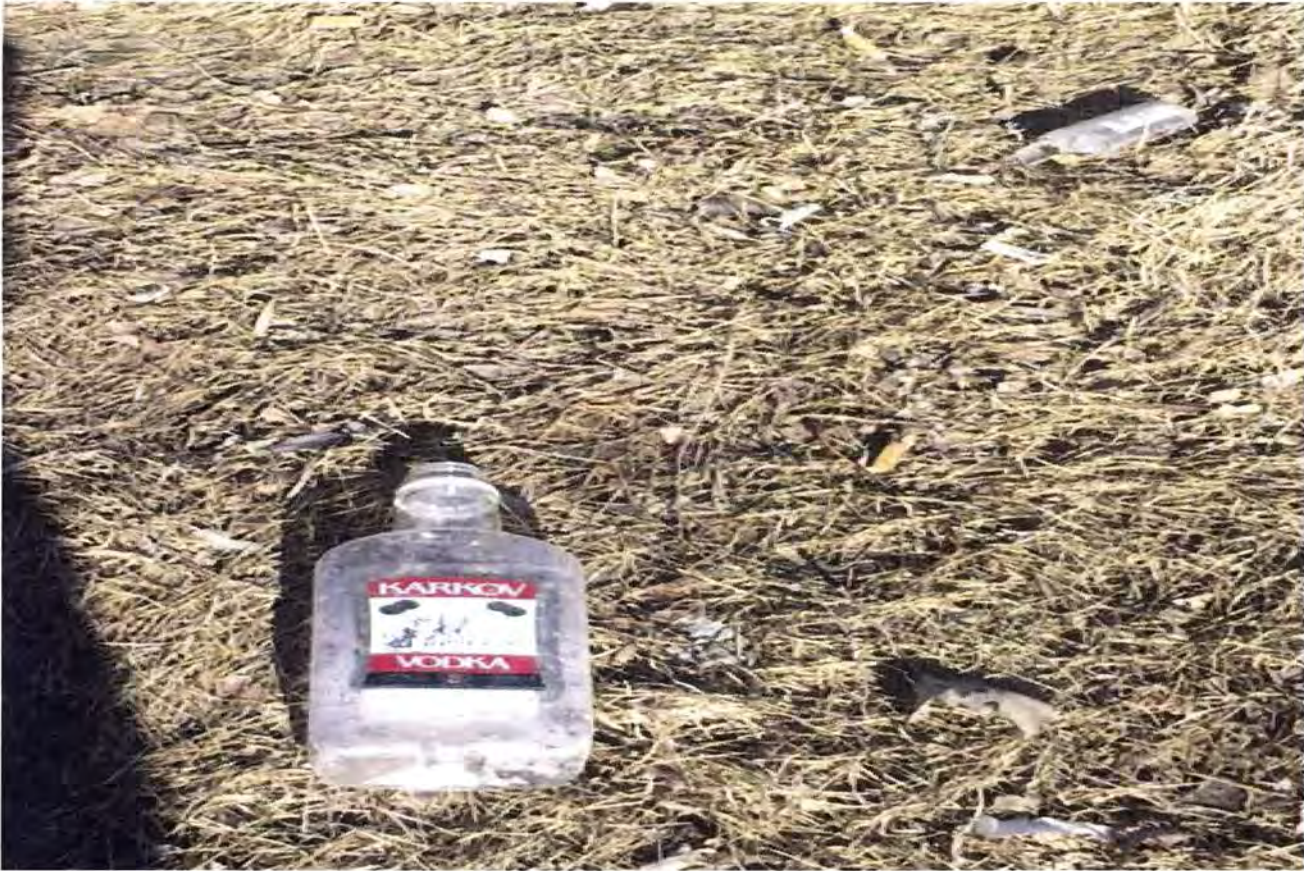
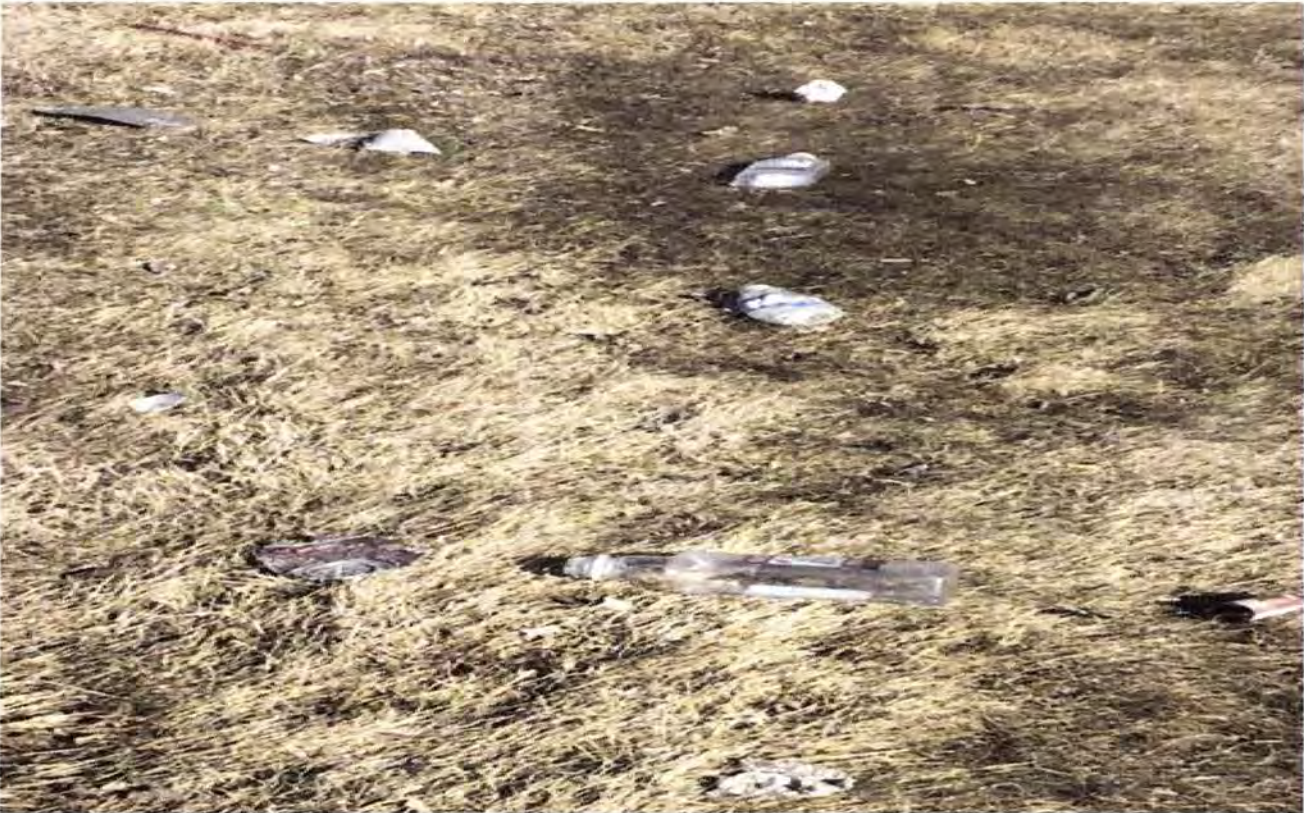
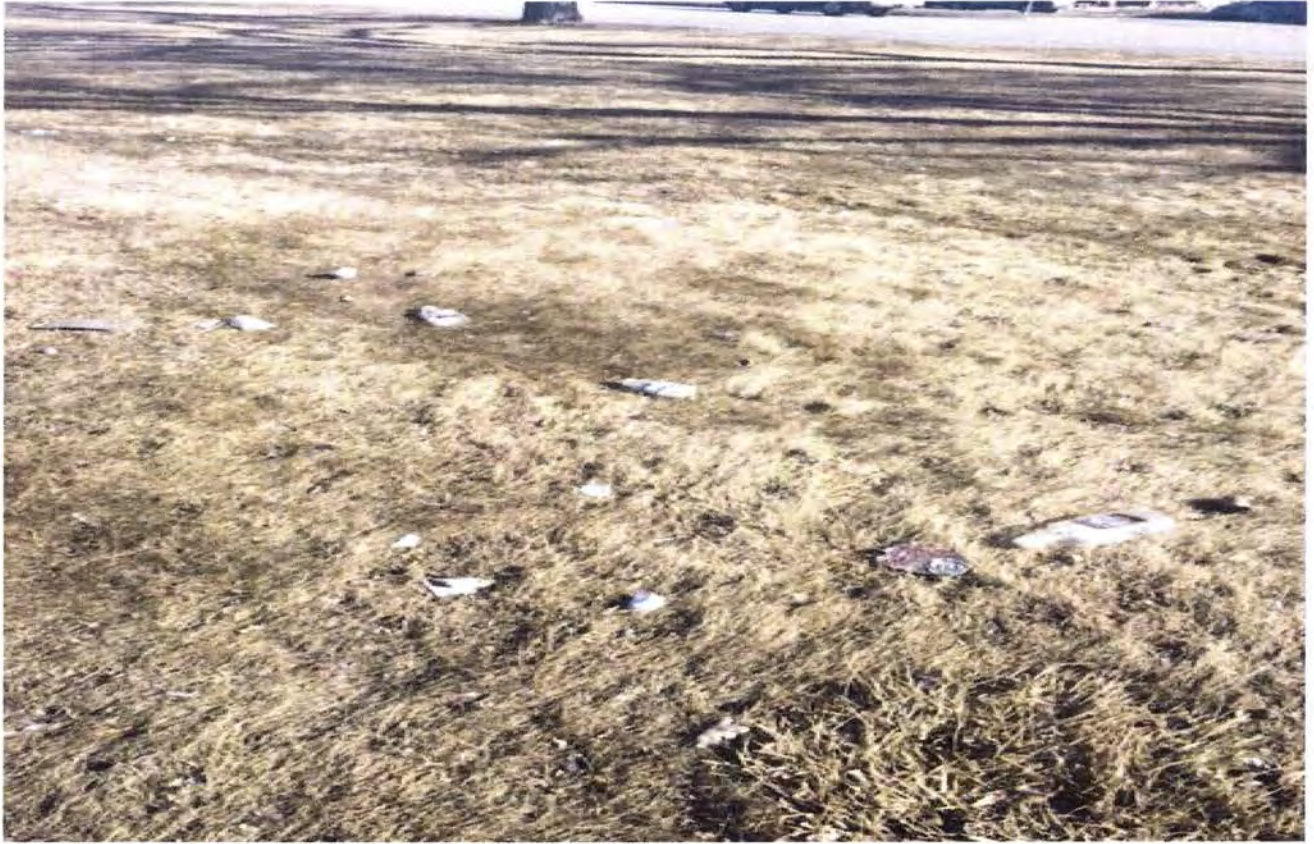
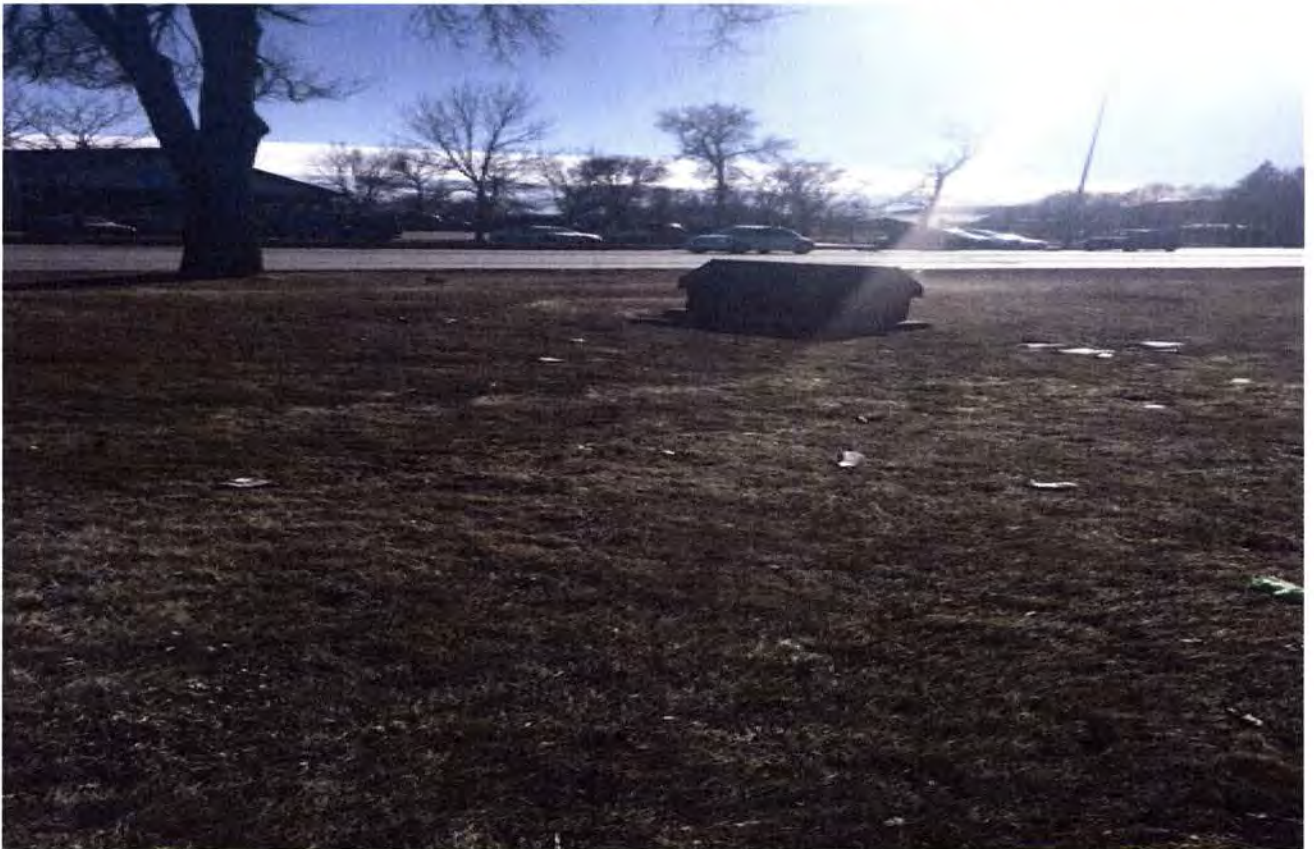
There was a grassy area to the east of the building and an electrical box. This property does not belong to Prairie Market. There is a curb and a sidewalk separating the property belonging to Prairie Market and the city. This is an area where a lot of the intoxicated subjects sit and consume alcohol illegally. This is evident with all the discarded trash and empty alcohol containers. This is also where we receive a lot of calls for service concerning passed out or intoxicated subjects and alcohol complaints. That is evident in how many empty alcohol containers were found in this area.

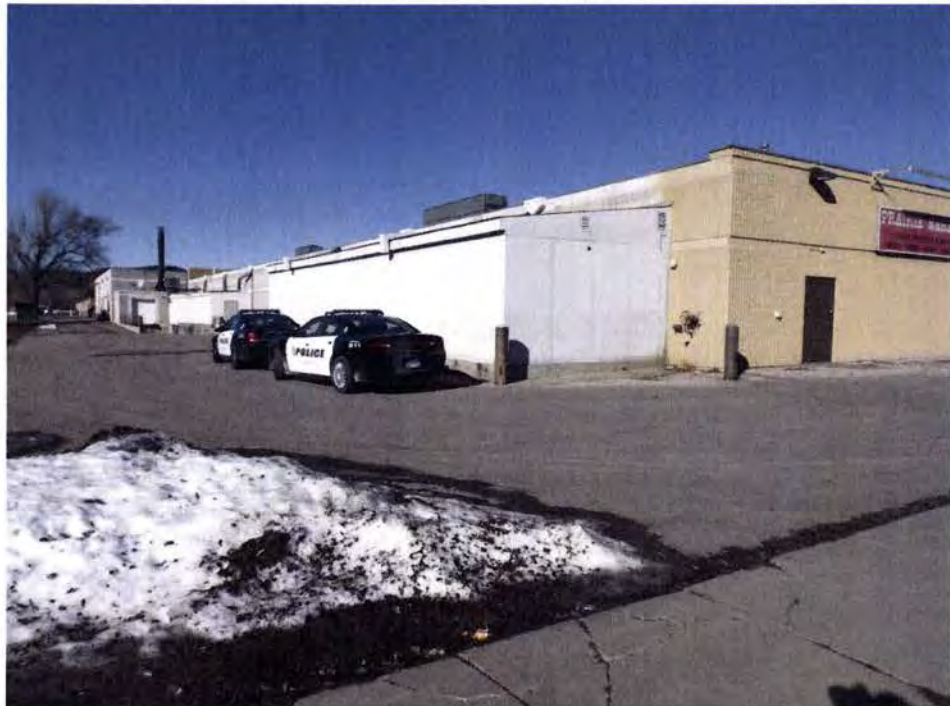
This is looking to the west from the southeast corner of the store.

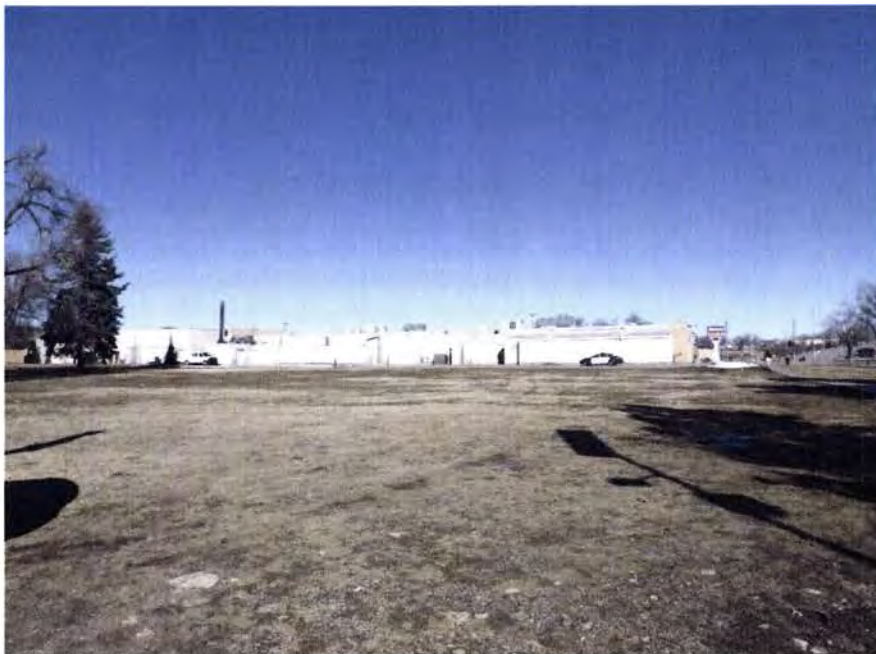
This is looking to the west from the southeast corner of the store. The end of pavement is the end of Prairie Market's property line.

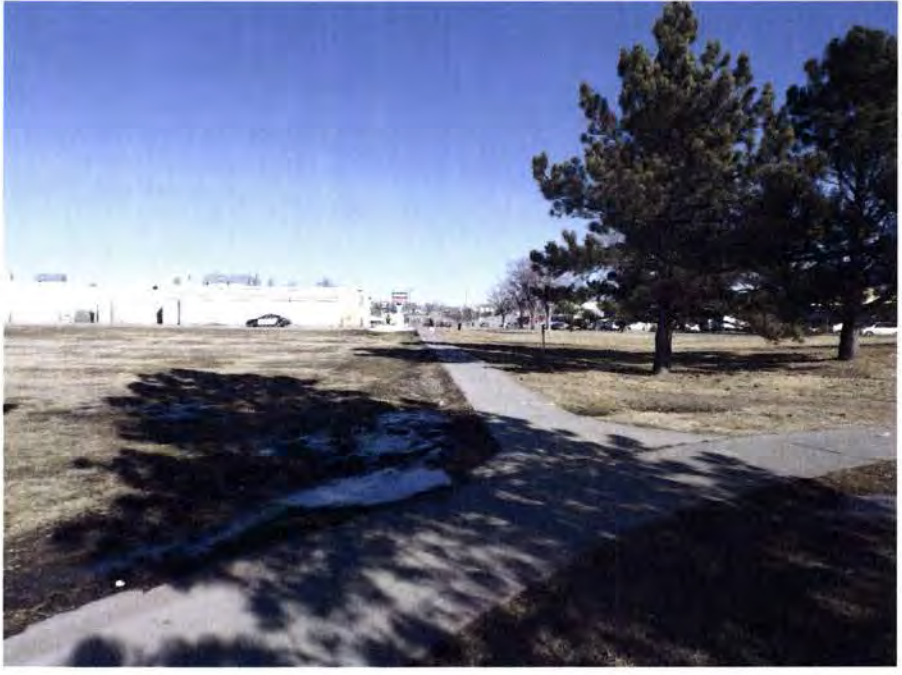
This picture is from the bike path near the East Blvd Bridge facing north, looking at the back (south side) of the store.

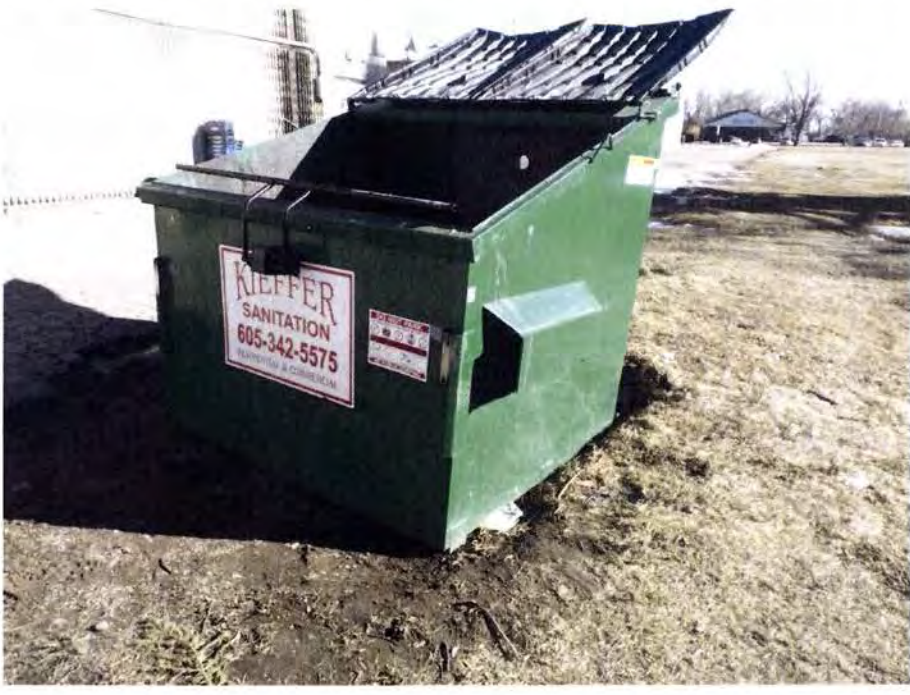
This picture is also near the East Blvd Bridge looking at the back of the store.

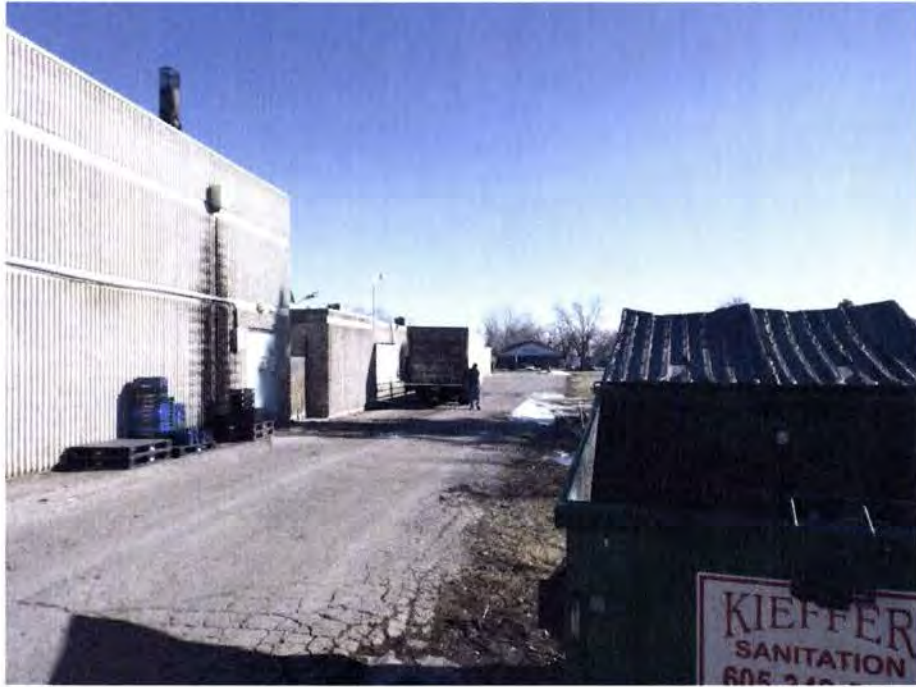
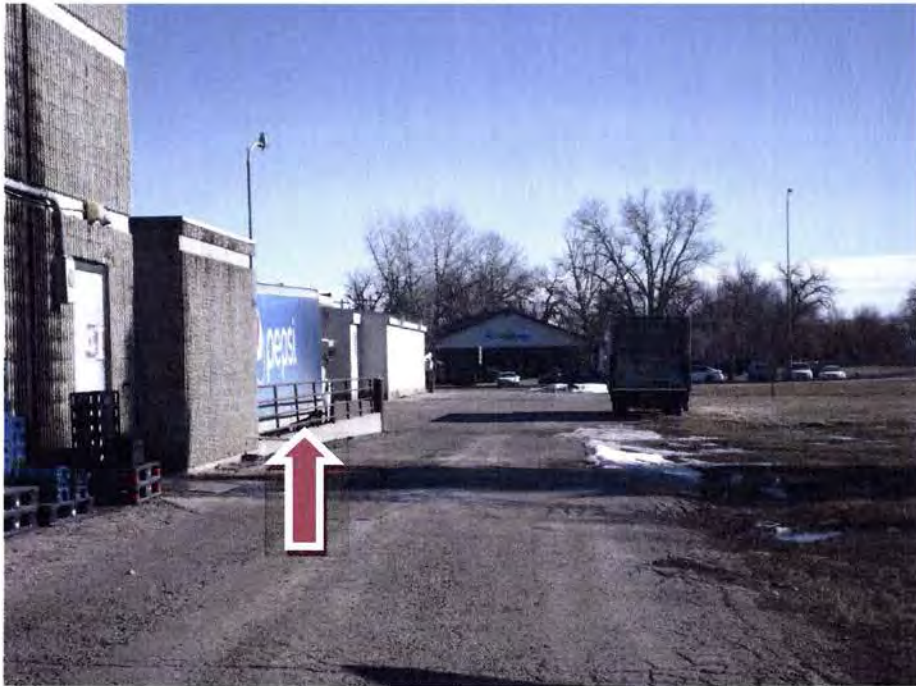
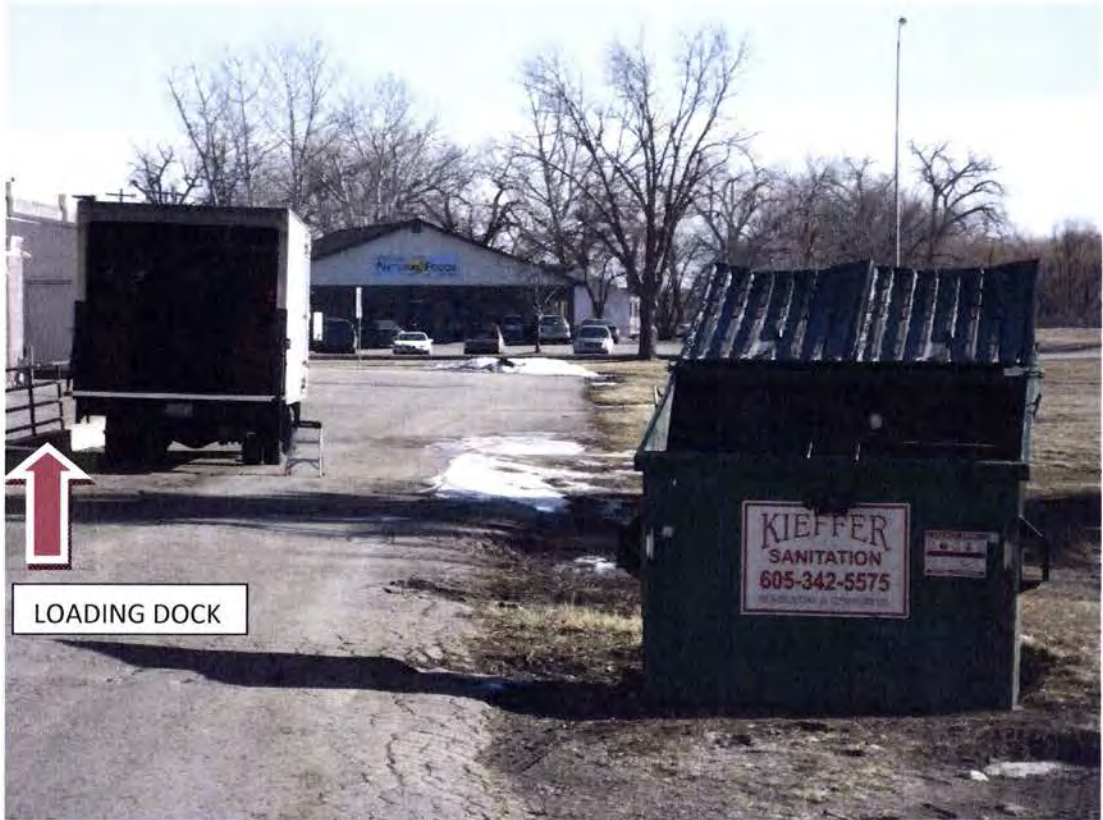
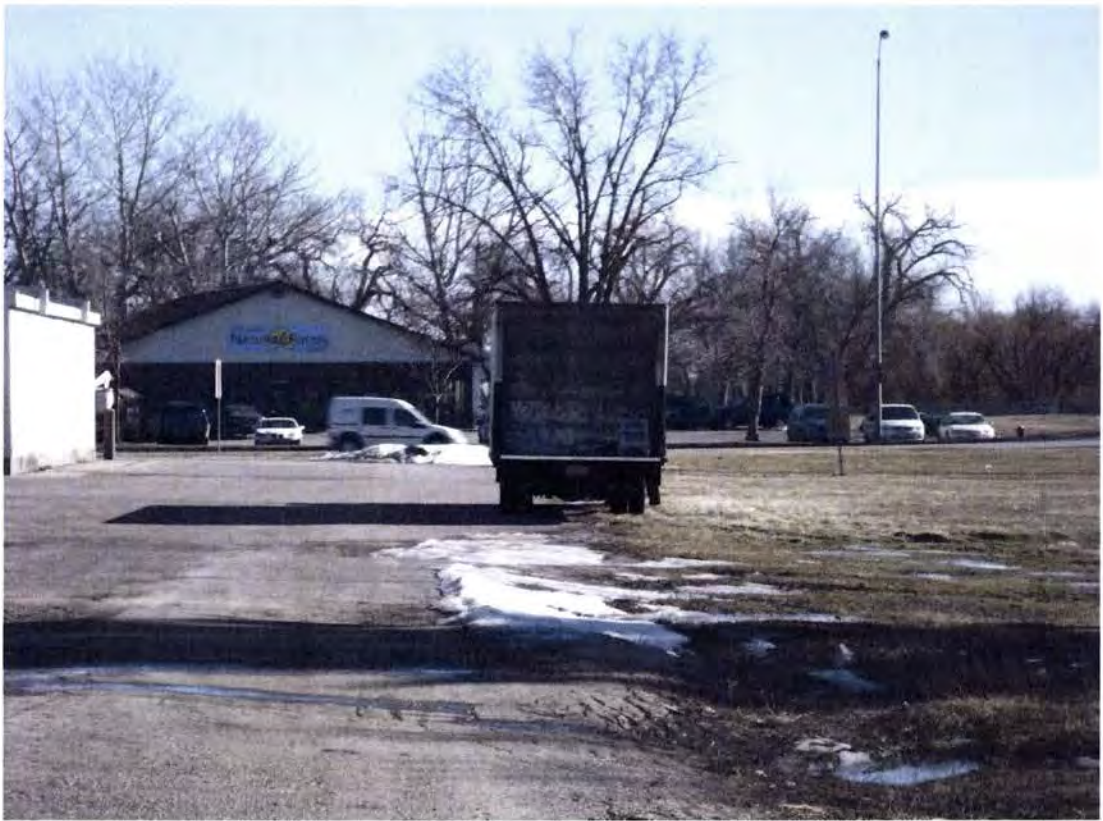
The following pictures below are looking to the east from the southwest corner of the store. As you can see there is a delivery truck parked in the rear of the building. There is no room to go around the trucks that park behind the store, unless you go in the grass area. This is a common practice for the trucks to park in the rear of the building for delivery.

The back area has high foot traffic in the rear of the building also. Putting a fence in the back area of the store would possibly help with keeping the high volume of intoxicated people sitting behind the store or loitering in the back area. The fence can also create the sense of ownership of the property and the majority of people will respect it. It will also help distinguish private property and public space.

We would like to suggest putting a chain link fence up that is at least six feet tall and to make sure it is of high quality. This would help with **Territorial Reinforcement** and **Access Control**. Pinning the lower part of the fence to the ground with stakes would also help with maintaining the structure of the fence. I would not suggest putting slats in the fence because you would lose the visual aspect (**Natural Surveillance**) to the park or to people hiding behind the fence. Understanding maintaining the structure of the fence will probably be constant at first and then dwindle off as time goes on. This is very important to the **Image and Maintenance** of the property. Keeping the fence structurally sound and maintained let's people know you take an interest in your property and want it to look good. This portion of the fence is only for the unit block of New York Street. I will talk about the hundred block of the New York Street further on in the report.

The business would also have to consider how delivery trucks are going to be able to get through the back side of the property. I would suggest Prairie Market make a policy for their delivery trucks to enter from the west side of the property and exit to the east side of the property. I say this because the semi trucks have to enter from the west in order to back in to the loading dock on the back of the store. I have seen where they have had three different delivery trucks in the back of their building and they were not all parked in the same direction. During these times, you could not pass through the back way, unless you went on the grass area where the fencing would be installed.

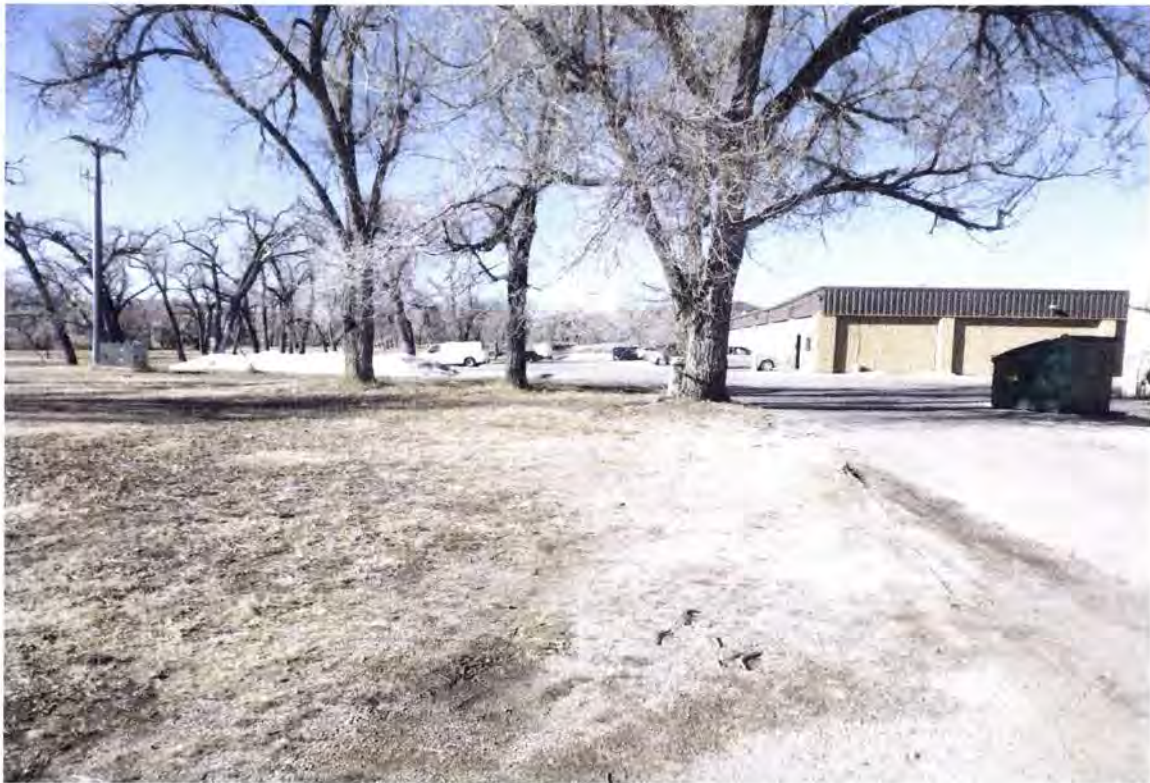
This is looking from the southwest corner of the unit block of New York St to the west. This area is where vehicles park and have to go around delivery trucks in the rear of the businesses. The Rent-a-Center delivery truck dock is in on the southwest corner of the property. I see no issues with this dock and vehicles being able to enter and exit the area, because there is plenty of room.

This dock has been an issue for alcohol violations because it can be used to hide in while consuming alcohol. It is an easy access point for foot traffic coming from the bike path and park area.

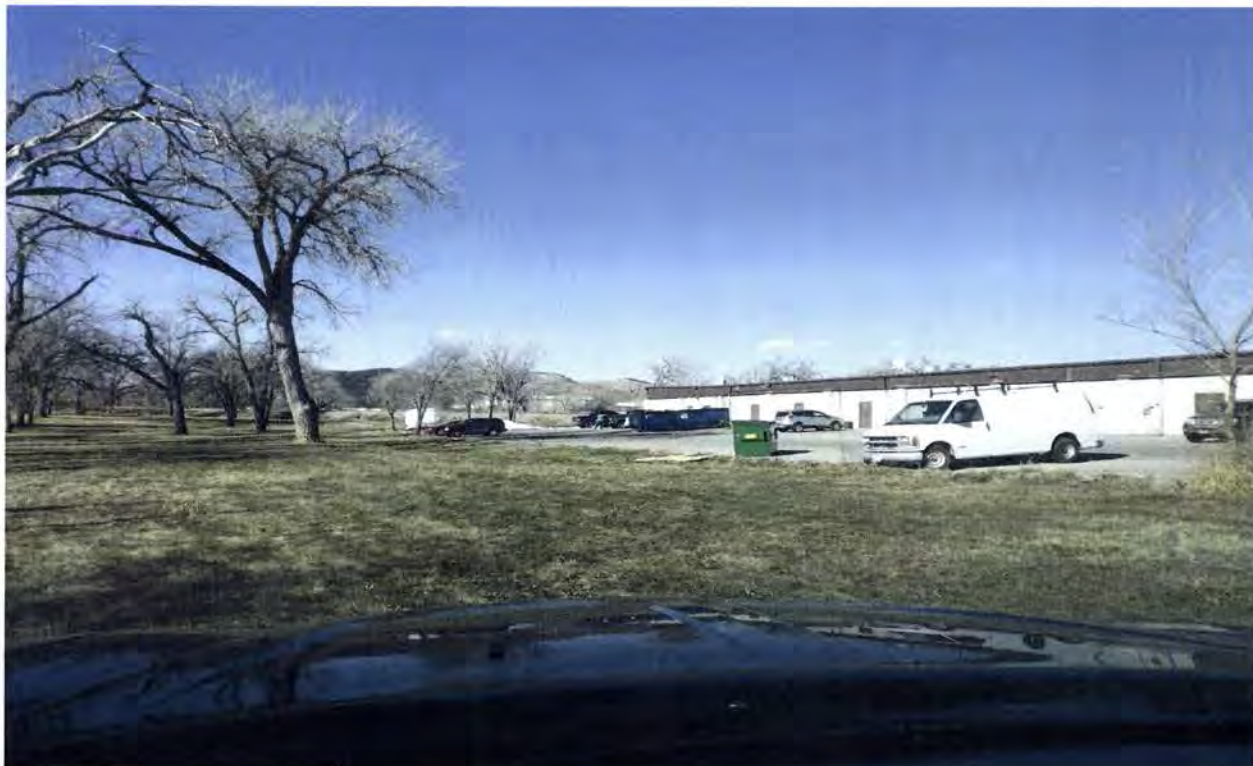
This picture shows the property line and the back (South) parking lot of the 100 block of New York Street. One thing should be noticed concerning this picture. The white van in the picture has been parked for approximately a year. It has flat tires and the back windows are completely broken in. As we know, this causes people to damage the property more often and the van has been burglarized several times. Having a fence in this area would help deter people from being in the parking lot during and after hours. If people don't have an easy way off property, they are less likely to do damage or commit criminal activity.

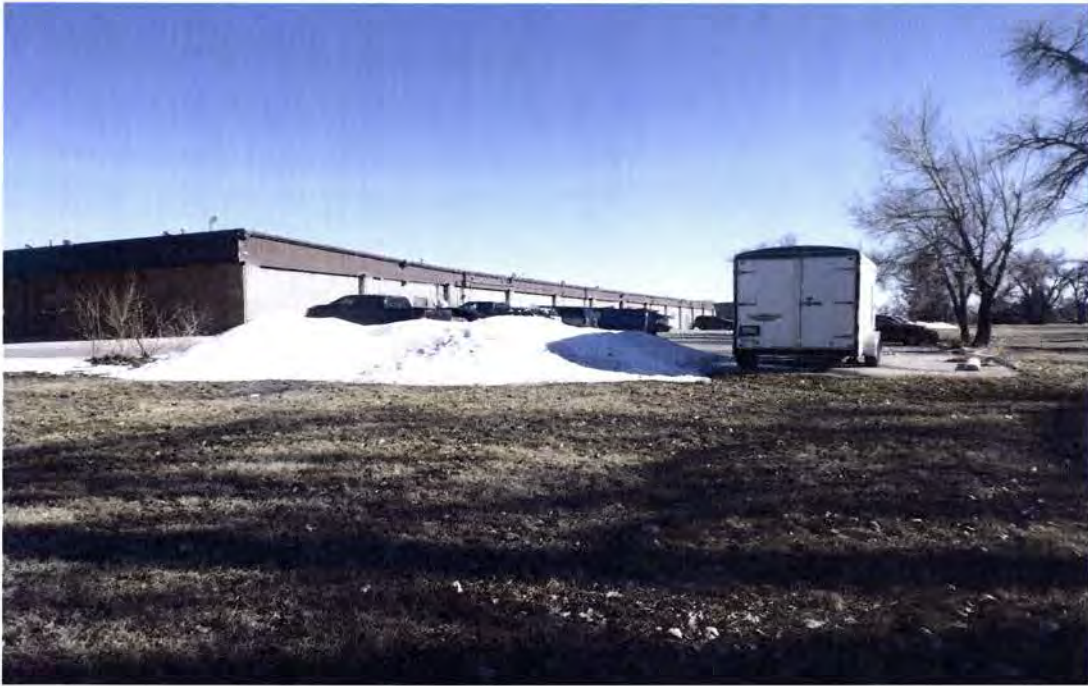
This is the southwest corner of the property. This area is also used as a snow removal area and the snow goes beyond the property line. Also there is a trailer that is stored in this area, however it is secured.

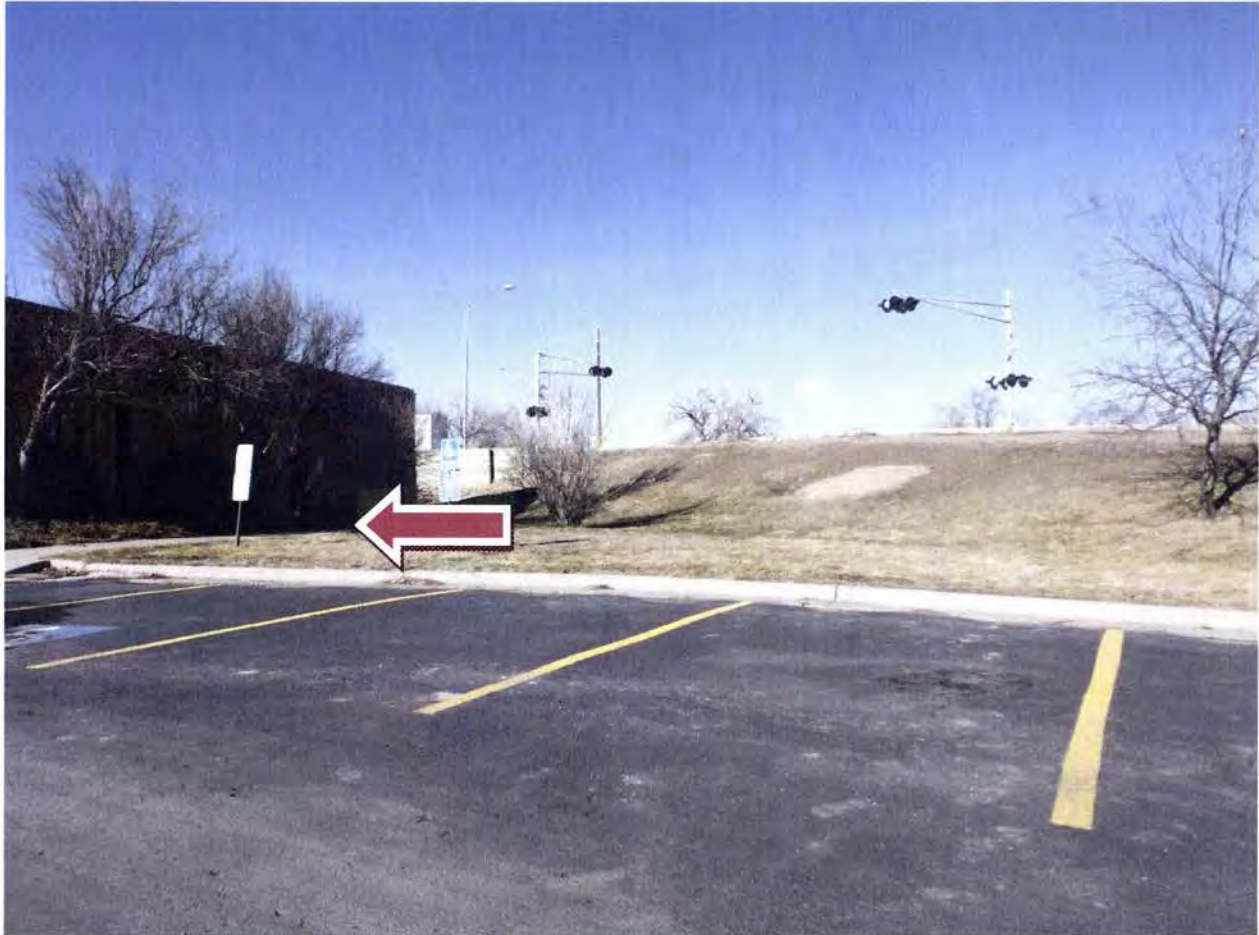
This is the northwest side of the property. This area is a high volume call area because of intoxicated or passed out subjects. We also have high calls for service in this area for alcohol violations. Also it is not visible from the road and a good hiding spot for criminal activity. We have also experienced some "tagging" and vandalism on the back of the building.

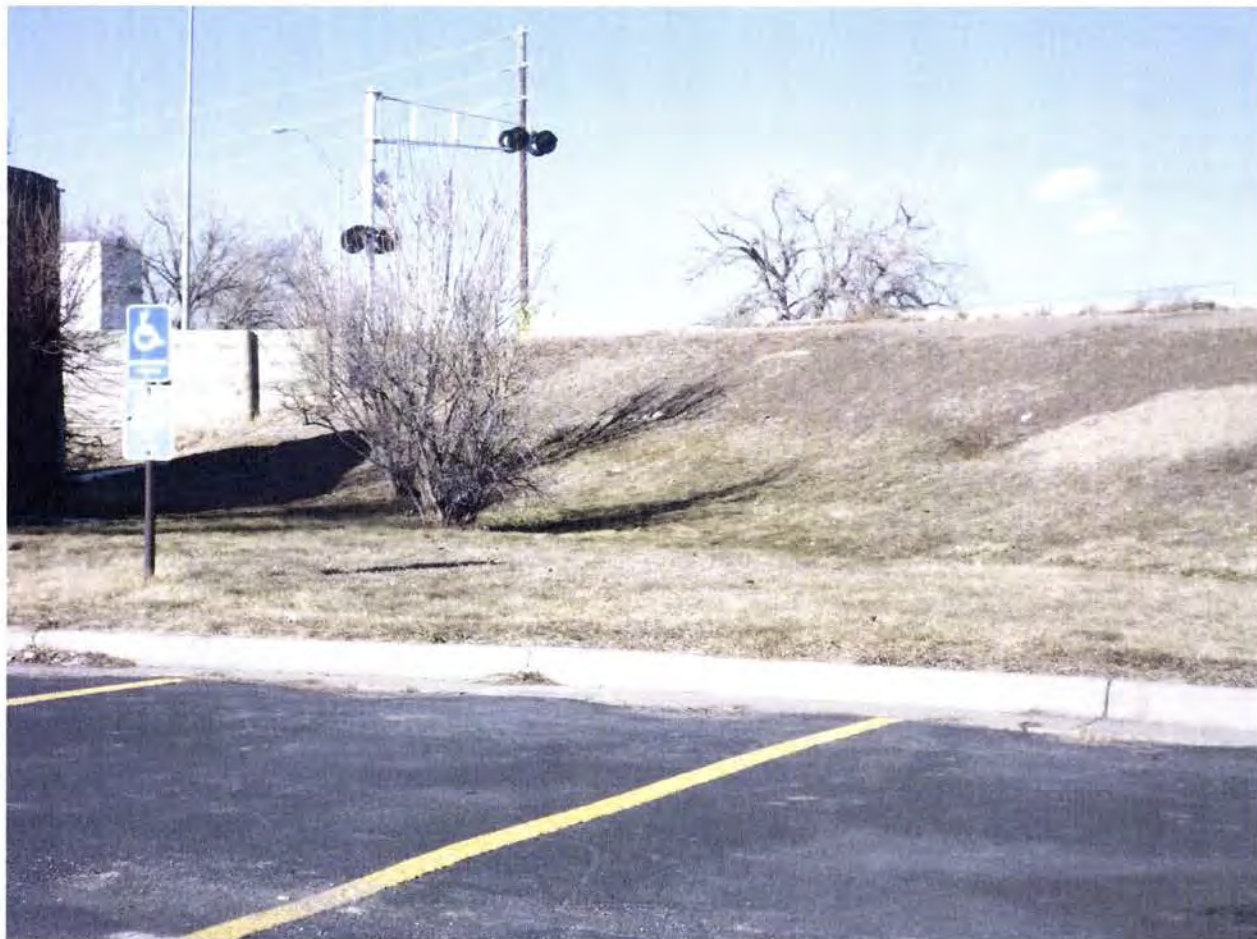
This is the northwest side of the property and again, this area has heavy foot traffic from New York St and from behind the building. Where the arrow is pointed is bushes and trees which are perfect hiding spots for intoxicated subjects. During the summer months, we found people living in this area. This is also a high call for service area for intoxicated subjects and alcohol violations. This is a good hiding spot for criminal activity. The bushes are overgrown and concealment for subjects is very good. We also cleared this area of debris and empty alcohol containers on several occasions.
