RAPID CITY DOWNTOWN AREA SURVEY

Pennington County, South Dakota

Quality Services, Inc. Project #SD3917005

April 12, 2017

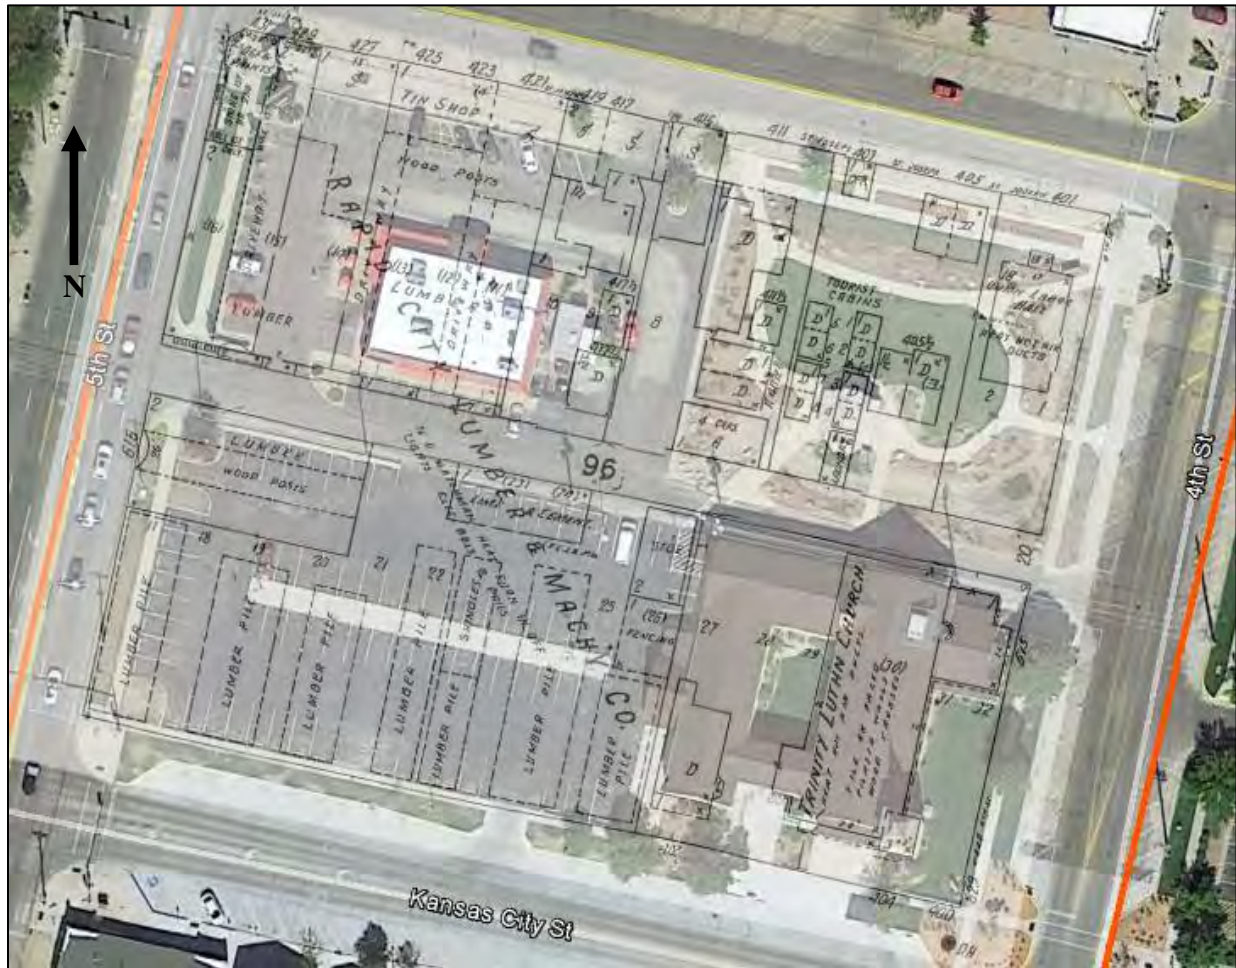
Figure 2. Overlay of Sanborn Fire Insurance Map on 400 block of Kansas City Street. Note that Trinity Lutheran Church is present in both periods. The tourist cabins, union hall and lumber company are no longer present however.

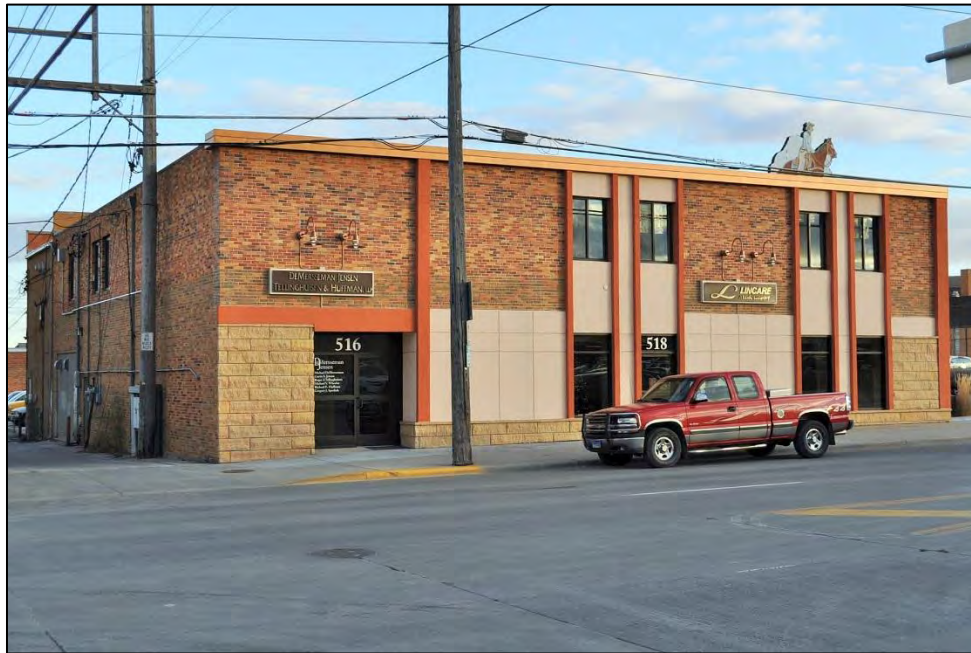
Figure 3. 518 5th Street (PN00000940) is an example of a building within the survey area which does not retain its historical integrity. B. Moloney 12/2/2016.

The above image depicts a building within the survey area which was found to be older than fifty years old but was determined to be not eligible based on its lack of historical integrity. Replacement doors and windows, and a concrete and stone veneer on the primary façade do not reflect or complement the building's Mid-20th-Century period of significance. These physical changes would also be extremely difficult to reverse.

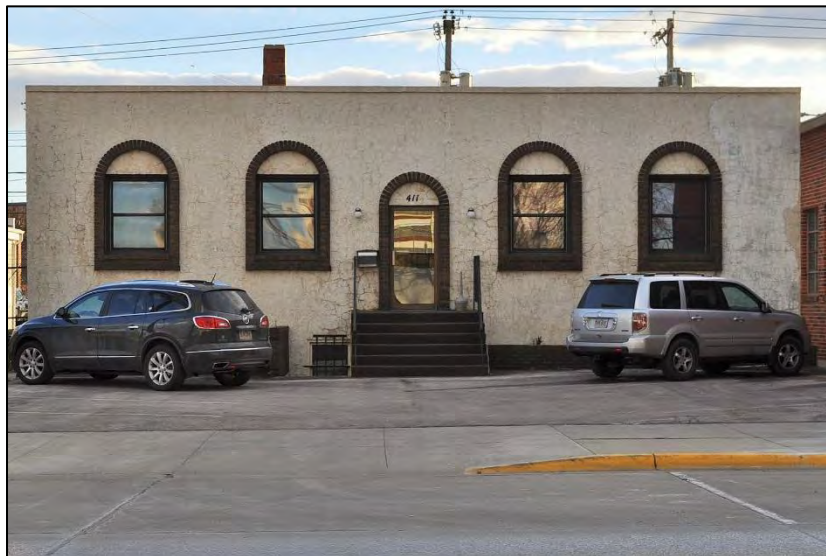
*Figure 11. The masonry walled building at 411 Main Street was constructed in 1915.
B. Moloney 12/2/2016*

A shift toward an increased use of masonry walls, particularly in commercial buildings, also occurred at this time. This shift was a fire prevention method and the result of further growth in regional businesses providing higher quality building materials such as the state-run South Dakota Cement Company, the Dakota Plaster Company in northwest Rapid City, and the Louis Volin brickyard. The oldest building within the survey area, at 411 Main Street (PN00000975) is a masonry commercial building built in 1915.

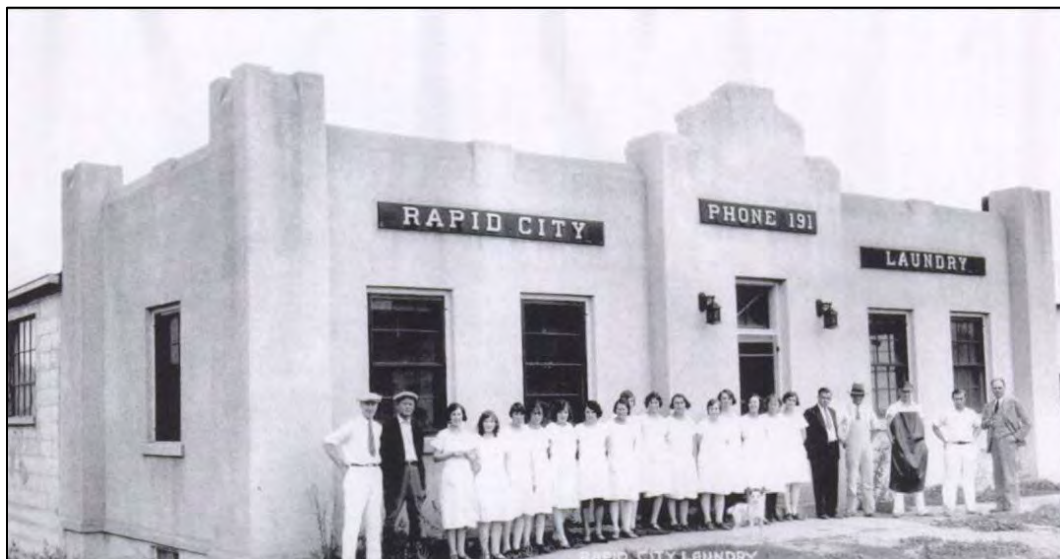
Figure 16. The Laundry was designed by Rapid City architect James Ewing in 1928 and built the following year (Kerst, Oleson-Kessloff and Roseland 2007).

Art Deco decorative elements appear in buildings of this period. This was a design movement which was the first expression of modernism in that it sought to break with the heavy ornamentation and pretension of previous styles. Common characteristics of this type include stylized geometric patterns in building lines and ornamentation, piers, parapet walls, and masonry construction, sometimes covered with a concrete stucco. Buildings with Art Deco influence within the project area include the Rapid City Laundry (PN00000263), The Garage (PN00000230), and Graphics Plus (PN00000935), among others.

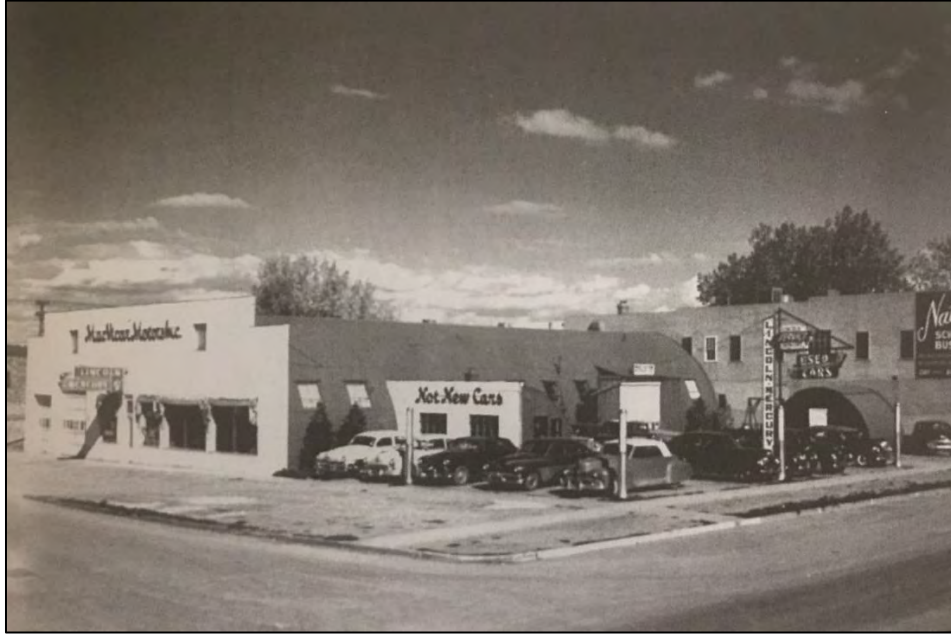
Figure 19. Late 1940s view of Quonset Hut at 516 4th St. (PN00000716) (Pechan and Groethe 2002).

The establishment of Ellsworth AFB also shaped the architecture of East of 5th. This included the use of Quonset huts, two of which are found in survey area. These are lightweight prefabricated structures of corrugated galvanized steel which have a semicircular cross-sectional roof. They were manufactured by a variety of companies for the US military and then sold as surplus after the war. The presence of these structures and their reuse as commercial and warehouse buildings is a remnant of Rapid City's close historical ties to Ellsworth AFB and the

important role it played in the city's growth. They also reflect an interest at the time in the development of industrial solutions to building needs. In East of 5th one of these structures is used as warehouse (PN00000973) while the other is a commercial building originally used as an auto dealership (PN00000716) (Figure 19).

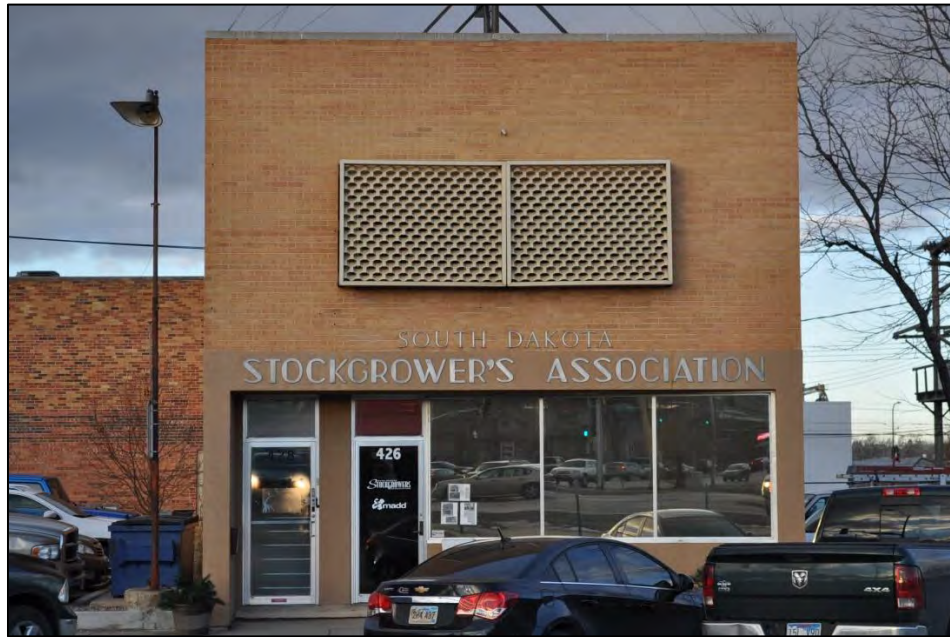
Figure 20. The Stockgrower's Association Building (PN00000929) possesses stylistic elements characteristic of Mid-Century Modern design such as plate glass windows and a small brise-soleil. B. Moloney 12/2/2016.

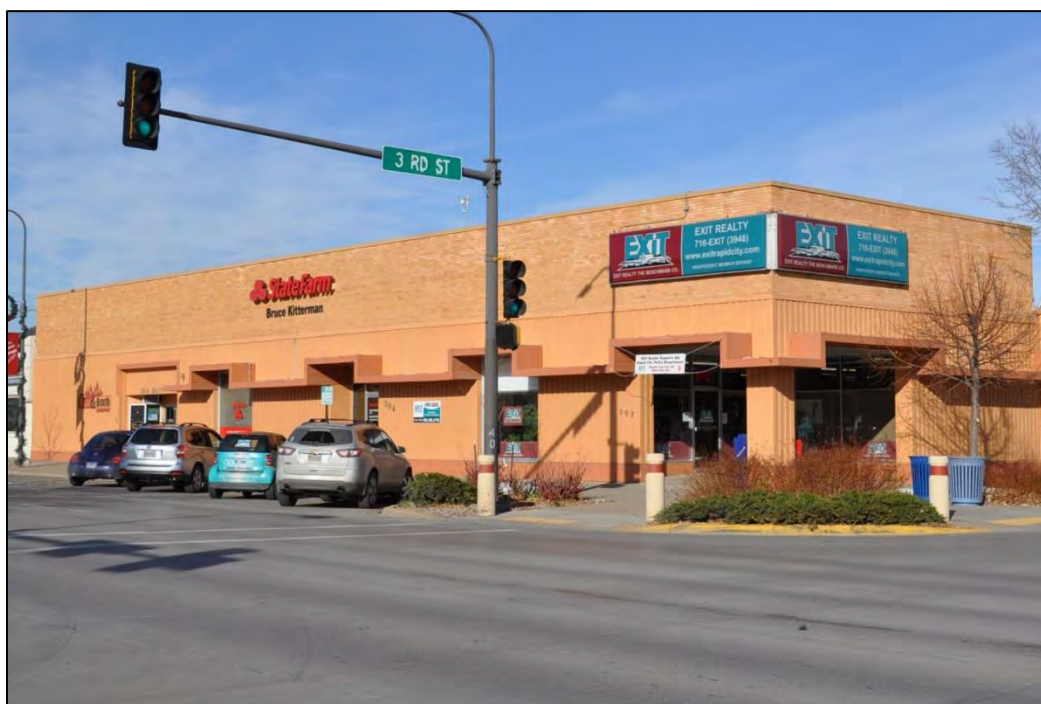
Figure 22. 302 Main St. (PN00000930) is an example of a post-war commercial structure composed of Quarnberg brick within the survey area. B. Moloney 12/2/2016.

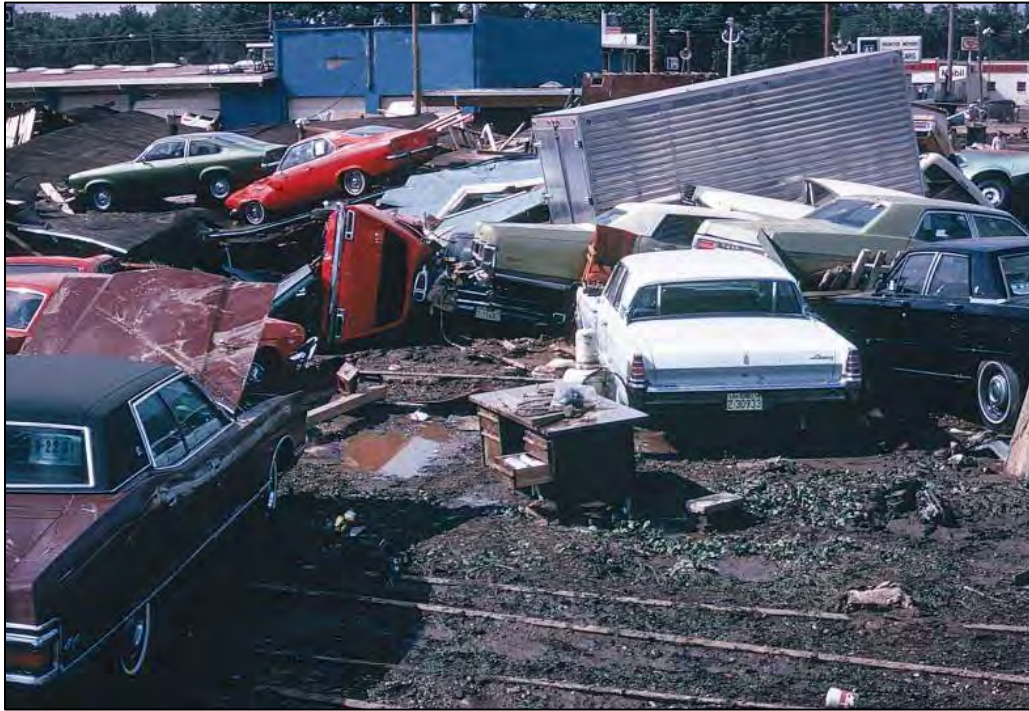
Figure 23. 1972 Flood damage at a car dealership on East Boulevard. (Carter, et. al., 2017).

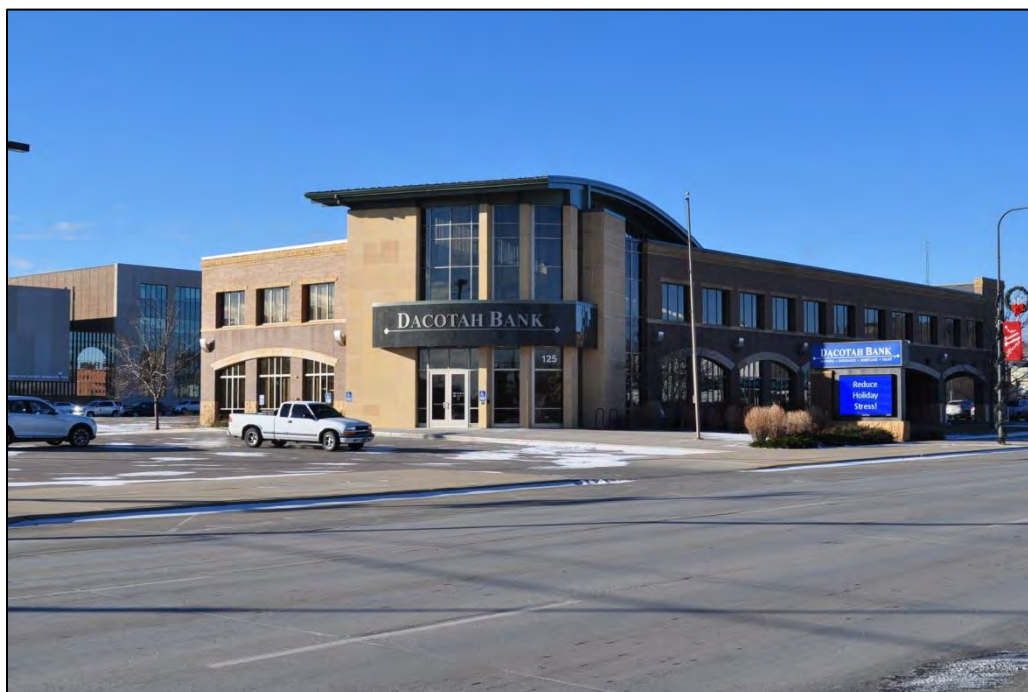
Figure 24. The Dacotah Bank at 125 Main Street is typical of the architecture constructed in East of 5th in the late 20th-Century and early 21st.

By the late 80s and into 2000s, the form of buildings constructed within the survey area took on a very different shape than previously. Overall massing was much larger and the buildings were oriented to spacious adjacent parking lots rather than to the street. Buildings which take up all or most of a block begin to predominate. Tuscany Square is a good example of this type of development as are many of the banks found in the survey area.

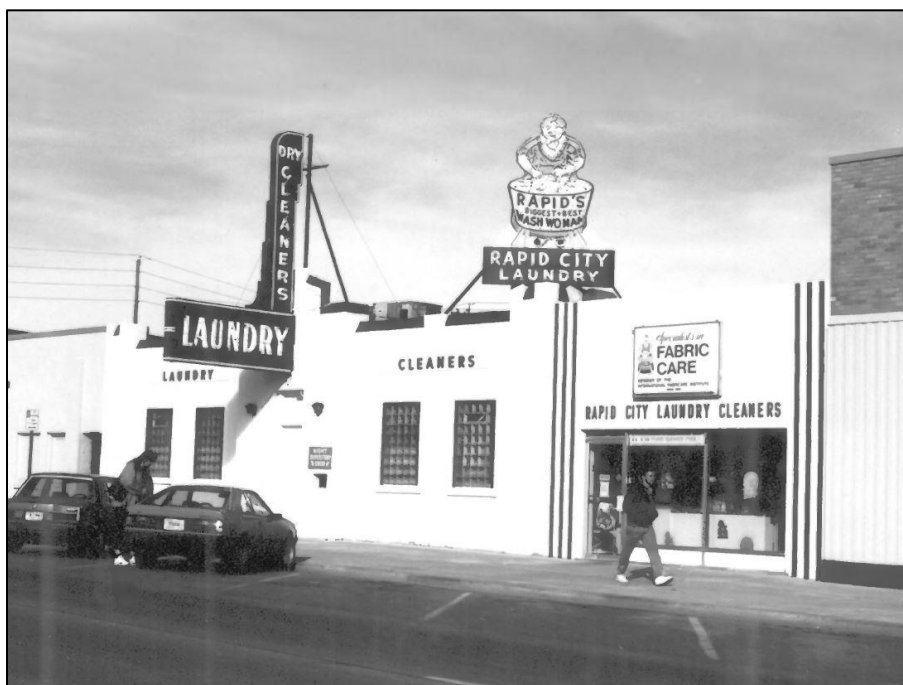
Figure 26. Photo of the Laundry at the time of its National Register nomination in 1995 (Butterfield et. al. 1995).

Many of the exterior details described in the 1995 NR nomination have since been altered. This includes the removal of two roof-mounted neon signs, replacement of the glass block with six-over-six double hung windows, restoration of the main entry door and transom light, and a reconfiguration of the entry and display window on the east addition. Two large exhaust units have also been mounted to the south elevation of the addition. The words ‘Laundry’ and ‘Cleaners’ which were once affixed to the south elevation of the building have been replaced by signs reading ‘Servall Uniform and Linen Supply.’ The small square tiles on the 1945 addition have also been removed. The glass block windows and main entry door have since been replaced with windows in keeping with its original character. The display window and entry on the 1945 addition have changed significantly while the striped tile surface treatment was also removed and exhaust pipes added. Most noticeably, the iconic neon signs which once graced the roof are gone. Despite these alterations, the building retains a high degree of integrity from the period of its significance.

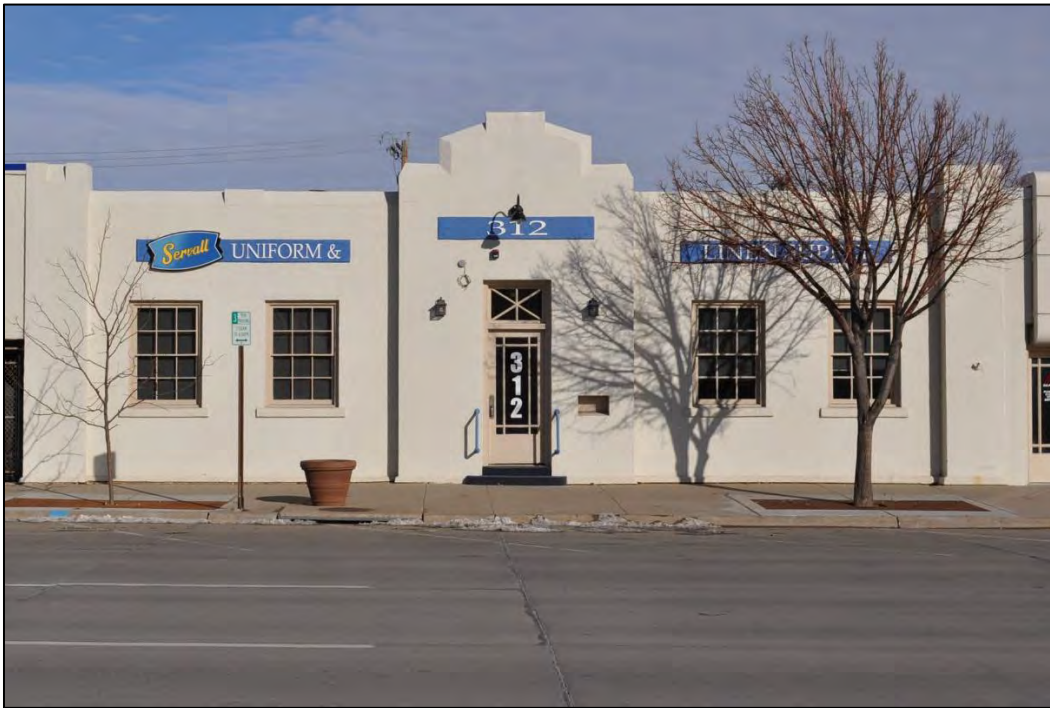
Figure 27. Site 18711 Structure 23506 at 312 Main Street, also known as the Rapid City Laundry or Kellogg Laundry, was listed on the National Register in 1995. This Art Deco structure retains its historic character.

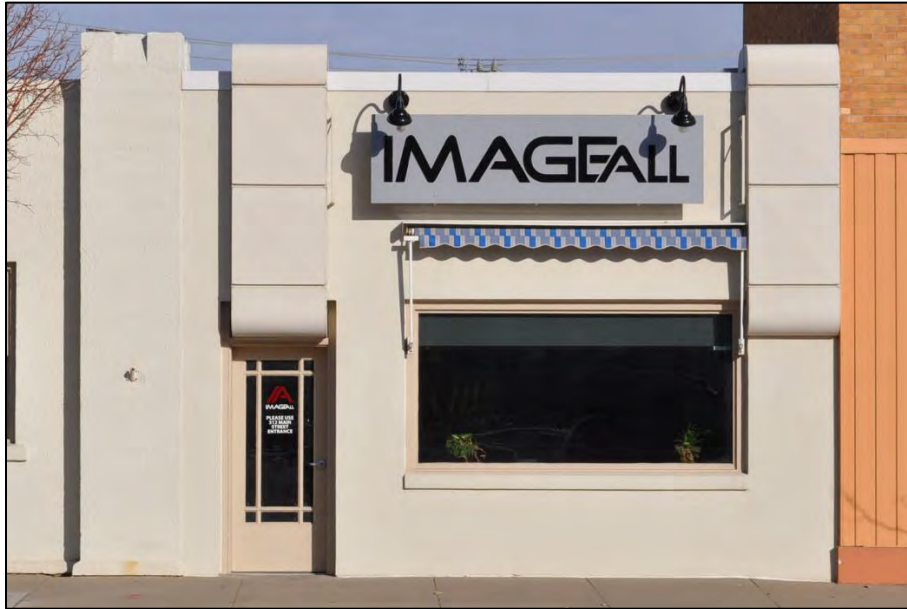
*Figure 28. The 1945 east addition to the Laundry was also designed by architect James Ewing.
B. Moloney 12/02/2016.*

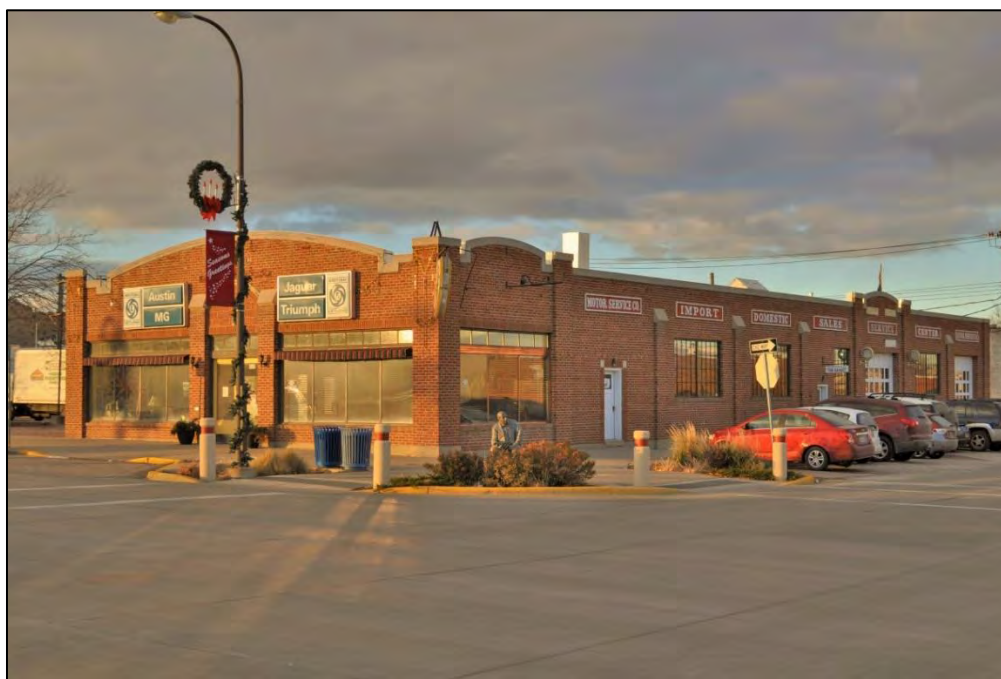
Figure 29. The Motor Services Company building at 402 St. Joseph looking northwest. B. Moloney 12/14/2016.

Very few changes to the building were observed. Windows on east elevation may be replacements but mimic previously recorded fenestration pattern. The Motor Service Company neon sign, located at the parking lot entrance to the west of the building, was not mentioned in the original nomination form but should be considered a contributing feature of the building. Overall the building retains a high degree of integrity.

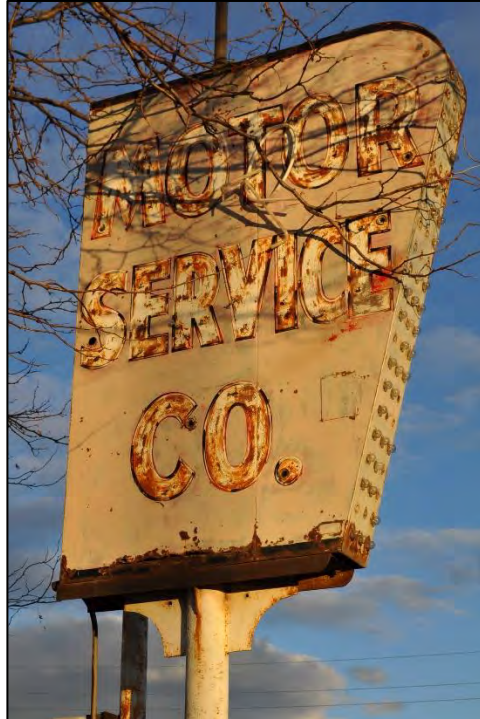
*Figure 30. Motor Services Co. sign located just west of the main building. B. Moloney
12/14/2016.*

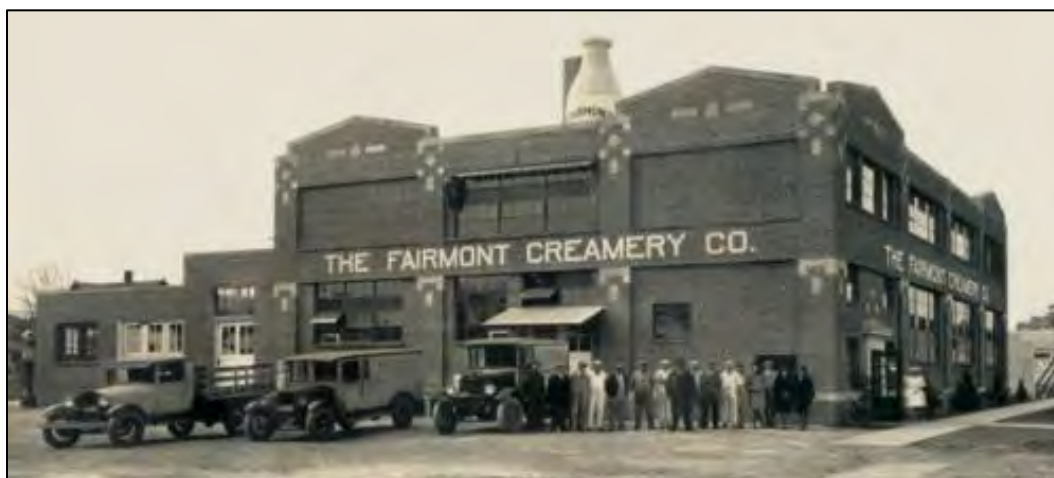
Figure 31. Historic view of 201 Main St. taken shortly after its construction (Kerst, Oleson-Kessloff and Roseland 2007).

The Fairmont Creamery Company Building remains much as described in the NRHP nomination. The only evident exception is that the windows previously infilled with wood and smaller units and/or glass block have been replaced with full sized windows that better represent the original factory windows. Large bay windows have been replaced with newer metal framed units that have decorative muntins and fill the entire openings. This restores the building’s character as the windows now look similar to those in place when the building was constructed in 1929. The awning over the entry door in the main façade has also been removed

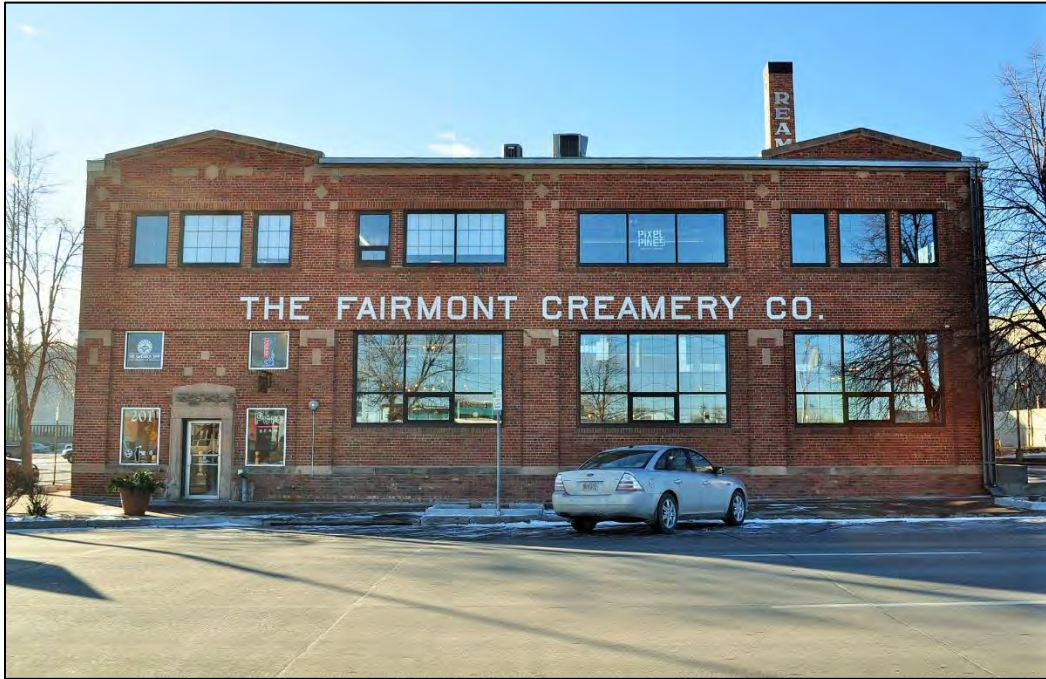
Figure 32. Site 28755 Structure 32306, 201 Main St. facing south. B. Moloney 12/14/2016.

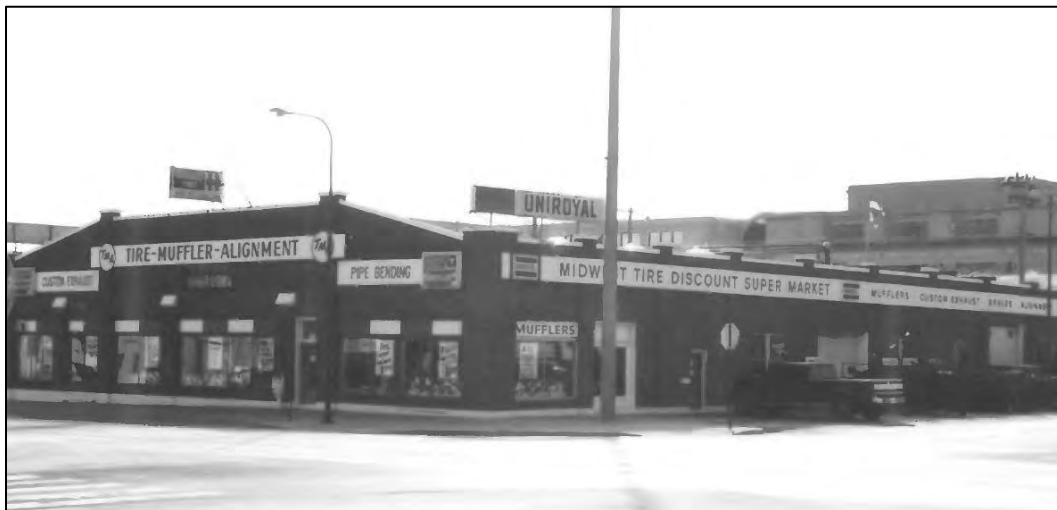
The Dean Motor Services building was built in 1929 and listed on the National Register in 1995 under Criteria C for being a fine local example of a Commercial Style building. The 1995 nomination form describes the building as measuring “100 feet x 140 feet and has a concrete foundation. The building is a modern broad-front commercial type, and is characterized by plain concrete and brick ornamentation. The curved steel truss roof is covered with tar. The interior of the building is divided into two main spaces, the showroom and office area, facing Main Street and the garage and maintenance area in the rear. The main (north) elevation of the Dean Motor Company building faces Main Street and is divided into three bays by two floor to roof pilasters. The main facade is distinguished by a parapet roof line, with concrete cornice, that angles on both sides to a raised central portion.”

Figure 33. 329 Main St.as seen at the time of 1995 NR nomination. (Butterfield et. al. 1995.).

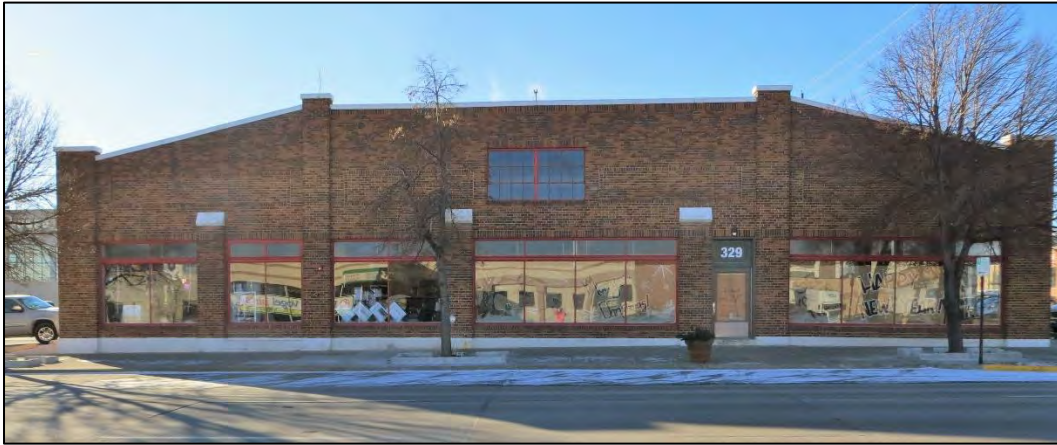
Figure 34. 329 Main St. facing south. M. Carpenter 12/13/2016.

Removal of signage and interior renovations have compromised the building's historical integrity and character but not to such an extent as to merit removal from the National Register.

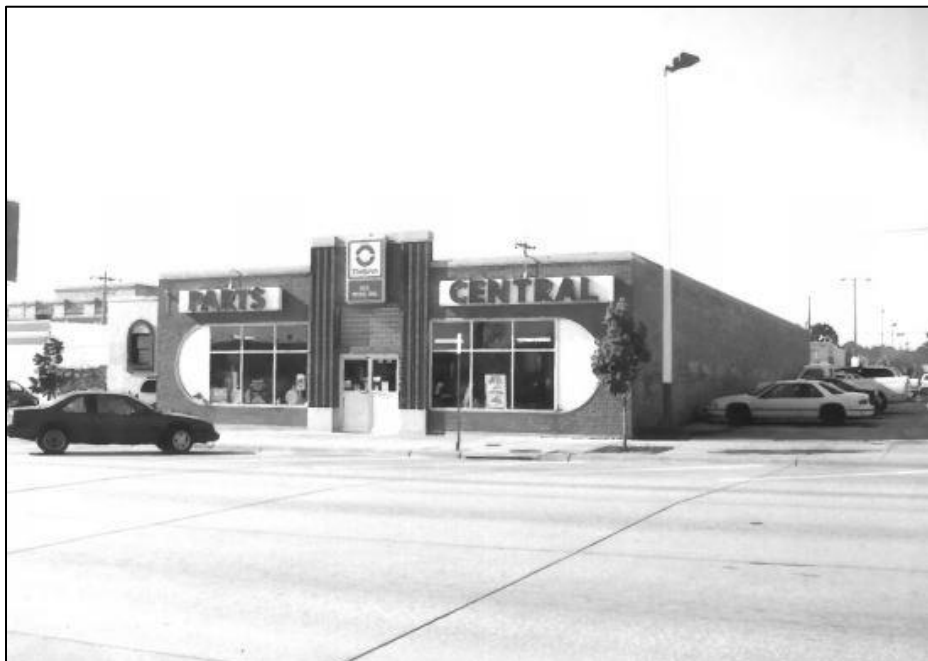
Figure 35. 415 Main Street as seen in the 2000 National Register nomination form. (Jeter and Rogers 2000).

The Parts Central building retains historical integrity and is in excellent condition. The National Register nomination prepared in 2000 describes the west elevation as having no openings but presently there are eight 1 over 1 metal frame windows. The west-facing façade has also been coated with a spray concrete stucco which was also not described in the 2000 nomination. The interior of the building was not examined for this survey.

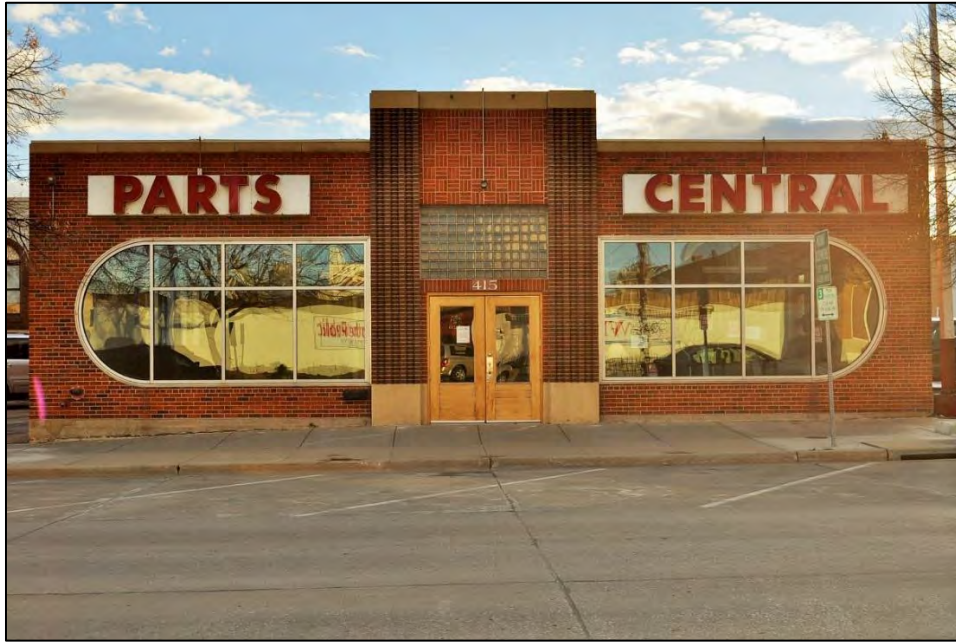
Figure 36. 415 Main Street facing southwest. B. Moloney 12/02/2016.

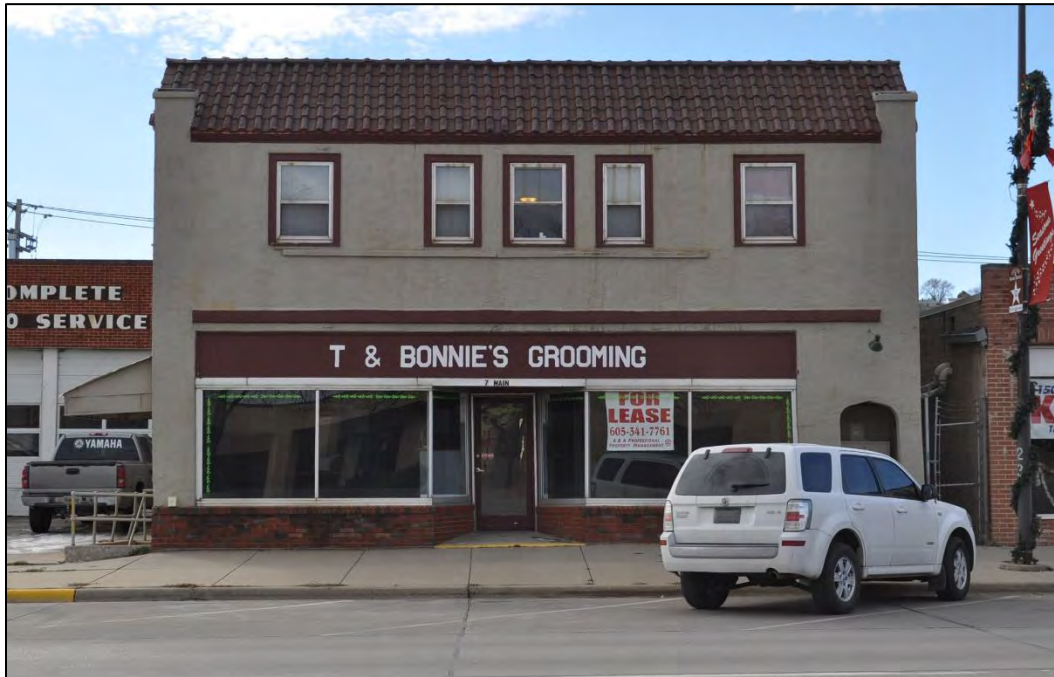
This is a unique example of a 1920s-era storefront with Spanish Colonial Revival influences. It is possibly the only remaining of its type in the city and is recommended eligible for the National Register under Criteria C.

Figure 37. 7 Main St. facing southwest. B. Moloney 12/7/2016.

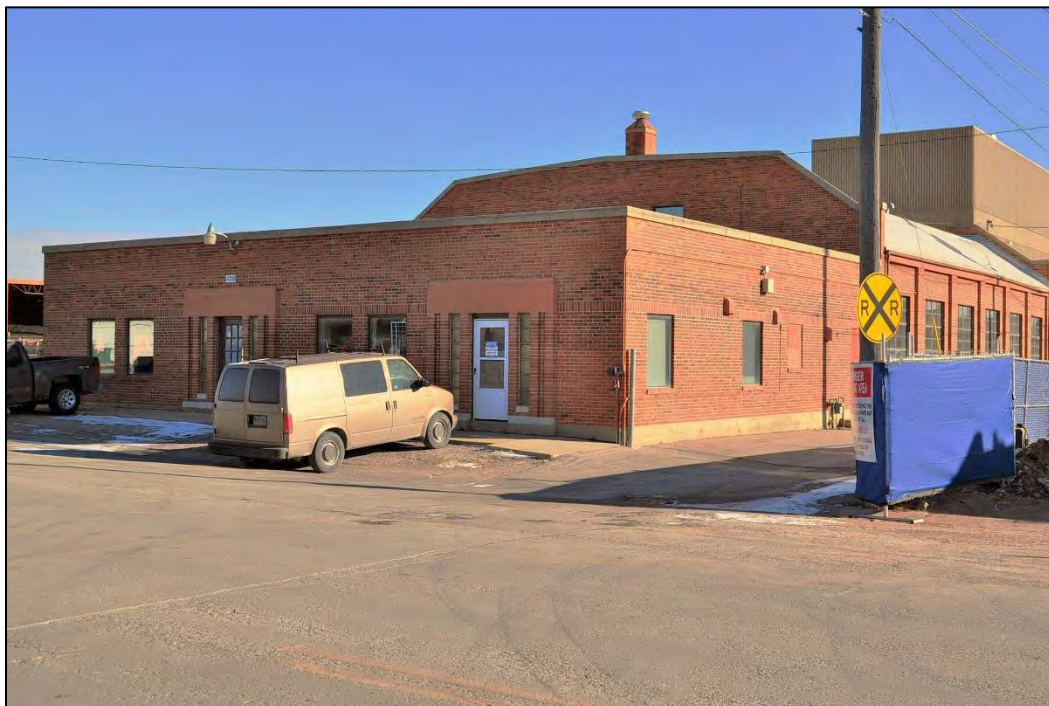
This is a fine example of early 20th Century local public works building that possesses a high degree of historical integrity and is in excellent condition. It is recommended eligible for the NRHP under Criteria C. Building is currently under private ownership. Like built circa 1923 and through at least 1948, the building was the Rapid City Water, Sewer and Streets Department Building. The west section was offices while the east portion was repair shop. Building appears on 1923 Sanborn Map however more research may be needed to complete a municipal context within Rapid City and to compare it to other buildings of this type within the city.

Figure 38. 408 2nd St. facing northeast. B. Moloney 12/7/2016.

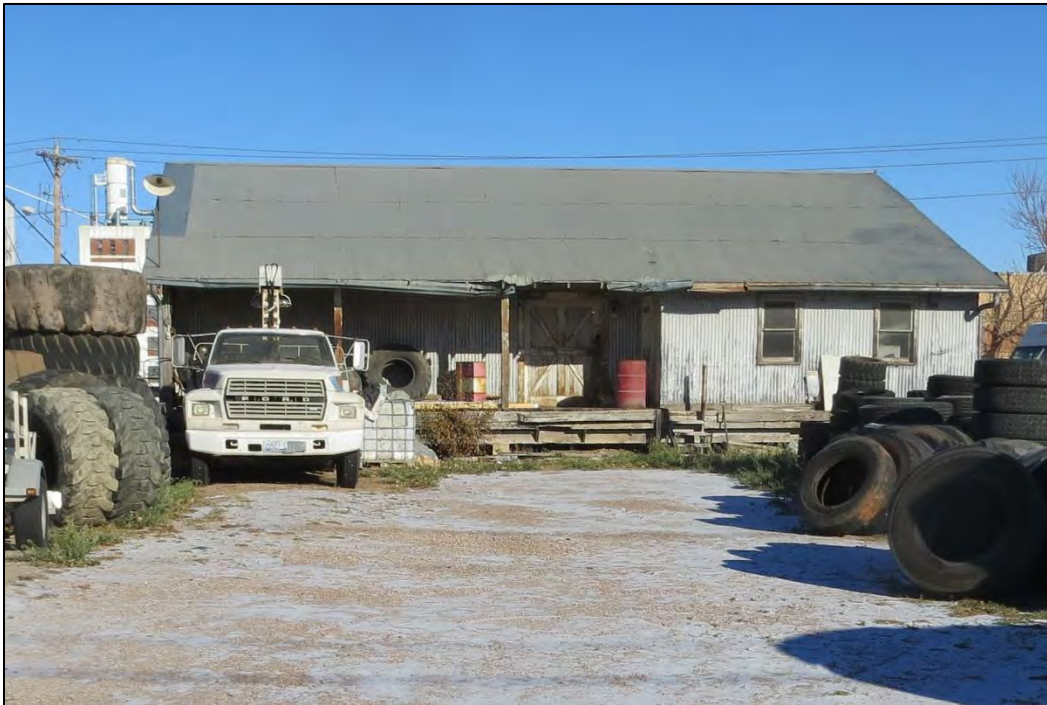
Figure 39. 415 4th St. facing northeast. M. Carpenter 12/4/2016.

It is a one story, gable end storehouse with corrugated metal siding and roof. Elevated on wood foundation. Wood door on north elevation facing railroad tracks. Two rectangular, double-hung, one-over-one windows on east and west elevations with. South elevation has a roof which extends over a recessed porch or loading dock. Two double hung windows on southwest elevation to the west of porch.

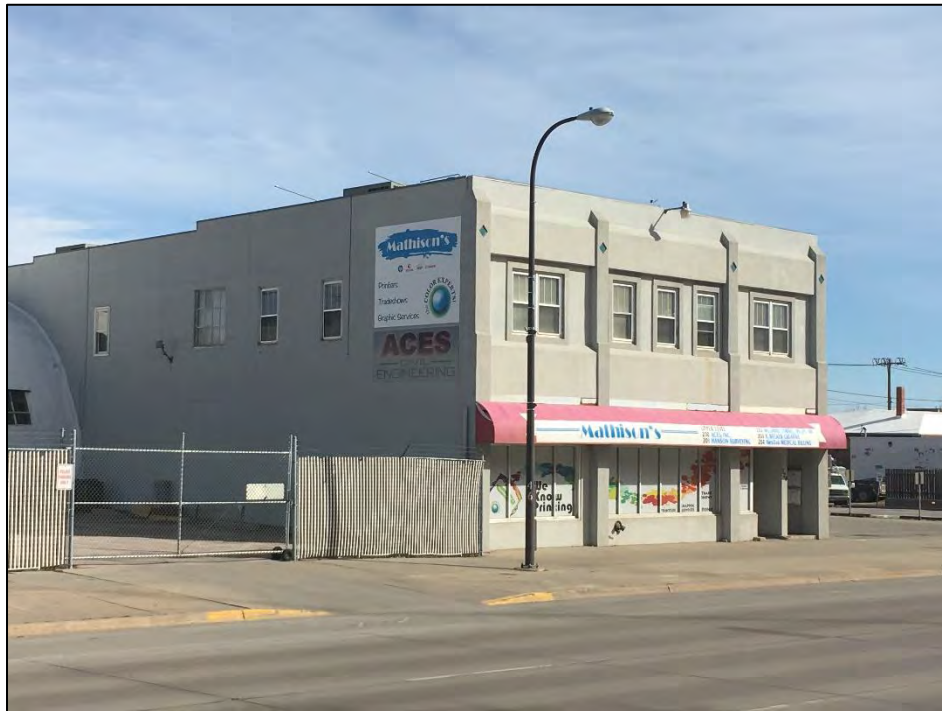
This building was constructed in 1941 and is a very good example of early 1940s commercial office building. In addition, the building also served as a business training school for returning servicemen and women after WWII. A determination of eligible for listing in the National Register of Historic Places is recommended under Criteria A and C.

Figure 40. 324 St. Joseph St. facing northeast. B. Moloney 1/11/2017.

Two story rectangular commercial building oriented lengthwise generally north-south. Primary elevation faces south to St. Joseph Street. Flat roof with stepped parapet exterior wall on west and east elevations. Art Deco influenced false and are circa 1940s aluminum cased units with segmented upper panes. Aluminum multi-pane storefront windows also appear original. Served as the National Business College in 1940s and 1950s. Noted on 1948 Sanborn Fire Insurance map as having an auto parts store on first floor and business school on second. in southeast corner, the left providing store access and the right access to upper floor. Single story square, concrete block, not contributing addition built in 1960 extends from main body of building on east elevation.

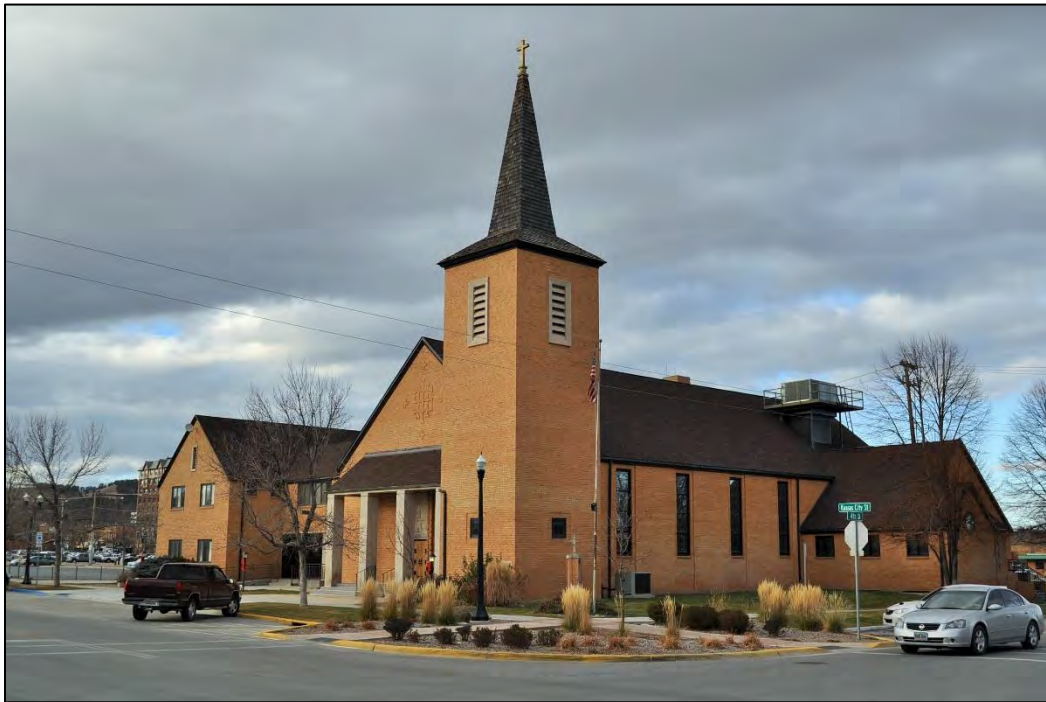
No changes were noted to the building. It retains a high degree of integrity and is in good condition. Built in 1947, Trinity Lutheran Church is a unique and elegant expression of Mid-Century liturgical architecture in Rapid City

*Figure 41. Trinity Lutheran Church at 402 Kansas City Street facing northwest. B. Moloney
12/02/2016.*

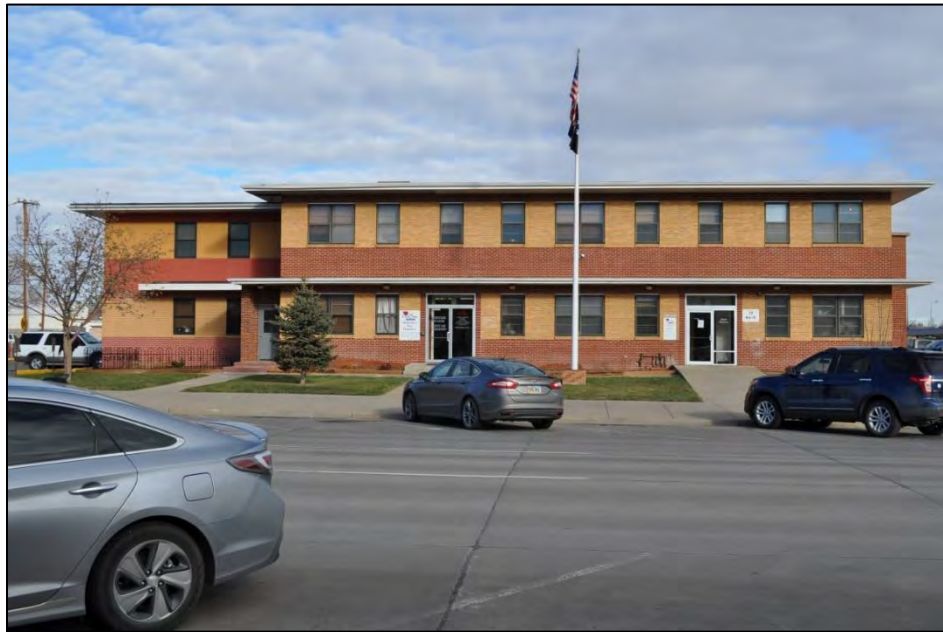
This building was designed by local architectural firm Ewing & Forrette and built by M.A Garland Construction for \$128,118 in 1955. The building displays characteristics of multiple important architectural trends from the first half of the 20th-Century. The cantilevered roof with wide eaves and alternating red and yellow brick courses give the building a horizontal aspect reminiscent of the Prairie style while the regular window placement and lack of ornamentation reflect Modernist or International influences. The building is a unique local expression of these design influences and is therefore recommended eligible for the National Register of Historic Places. The addition to the west elevation of the building is compatible with the original structure and is easy to differentiate and does not compromise the overall historical integrity of the building.

Figure 42. 30 Main St. facing north. B. Moloney 12/7/2017.

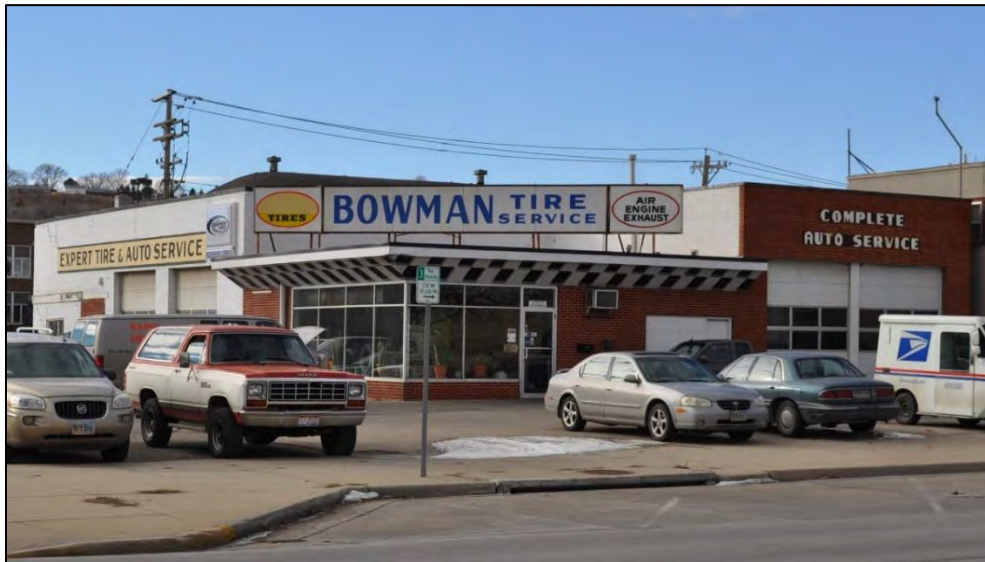
This is a good example of a 1950s-era service station and garage and is recommended eligible for the NRHP under Criteria C. Before a nomination could proceed, a 1950s-commercial context should be developed in order to understand the building's larger place in the development of Rapid City.

Largest portion of the building is two vehicle repair bays with concrete block walls and appear original. Former person entry door on east side has been converted to a window. This entry was surrounded by a brick veneer, while the remainder of the wall is painted concrete block. A slit window with paired side by side units is in the southeast corner. Several cracks are forming in the mortar seam between blocks. The sales floor portion of the building, in the northeast corner, is made of brick and is about five feet shorter than the rest of the building. It has large pane aluminum frame show windows on both the east and north sides. The person entry door on the north side, and is an aluminum cased glass unit with a light above. The cornice of the sales floor extends about three feet from the wall and has a slanted facia with a checkerboard design reminiscent of a diner from the 1950s era. A narrow horizontal billboard type sign sits atop the roof of the sales floor. The western portion of the building is another two vehicle maintenance doors that also appear original. All four vehicle entry doors have six windows in in the center.

Figure 43. 3 Main St. facing southwest. B. Moloney 12/7/2016.

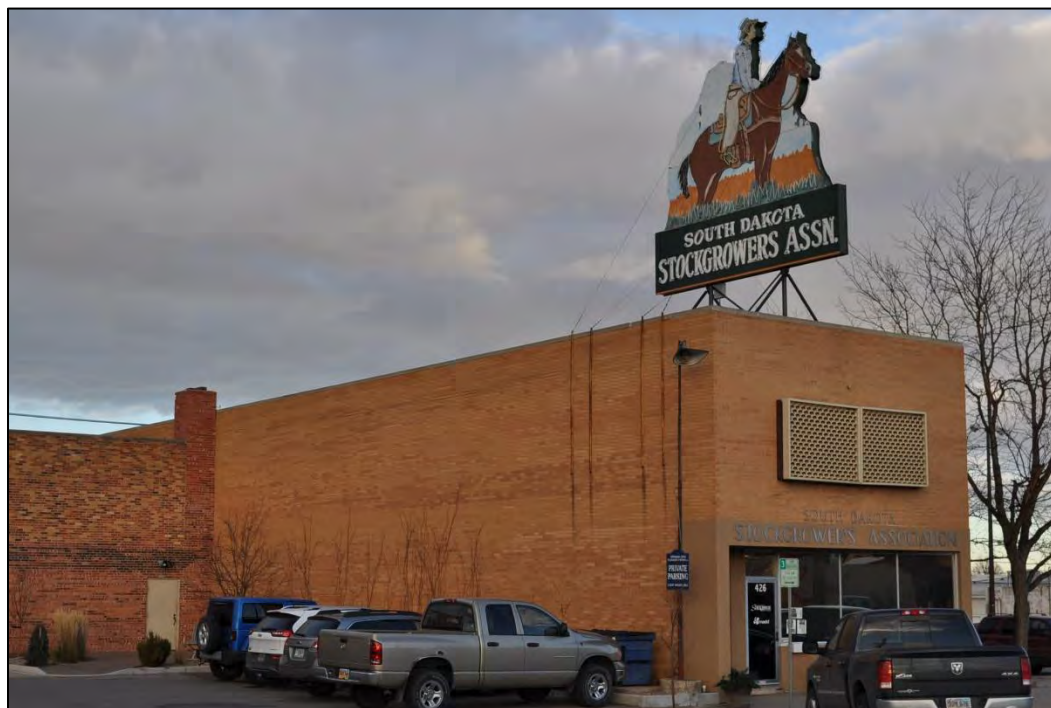
Figure 44. 426 St. Joseph St. facing northeast. B. Moloney 12/2/2016.

The building is a two-story rectangular commercial block building with Mid-Century Modern decorative elements on its southwest, street-facing facade. There is a recessed marble entry with glass wall windows and doors set in brushed aluminum frames on the southwest elevation. Separate entrance for second story walk up on west side of south west facing façade. Name of organization is centrally set above entry in brushed aluminum characters. 'SOUTH DAKOTA' is smaller, all caps in serif script and set into the brick wall. 'STOCKGROWER'S ASSOCIATION' is placed on the marble, extends nearly the full width of building, and is composed of stylized sans serif script in all caps. A small, two-part bronzed *brise soleil* perforated metal screen is centrally placed on the second story of the street-facing, southwest façade possibly obscuring a window. A two-story scenic neon sign depicting a cowboy on a horse and displaying the organization's name is mounted to the roof at the south end of the building. The sign is oriented north-south. A street light possibly dating from the same period as the building is immediately adjacent to the southwest corner of the building. There are four single light square windows on the second story of the northeast facing façade. Three smaller square windows with 1 by 1 replacement frames are on the first floor of the same façade.
