RAPID CITY DOWNTOWN AREA SURVEY

Pennington County, South Dakota

Quality Services, Inc. Project #SD3917005

April 12, 2017

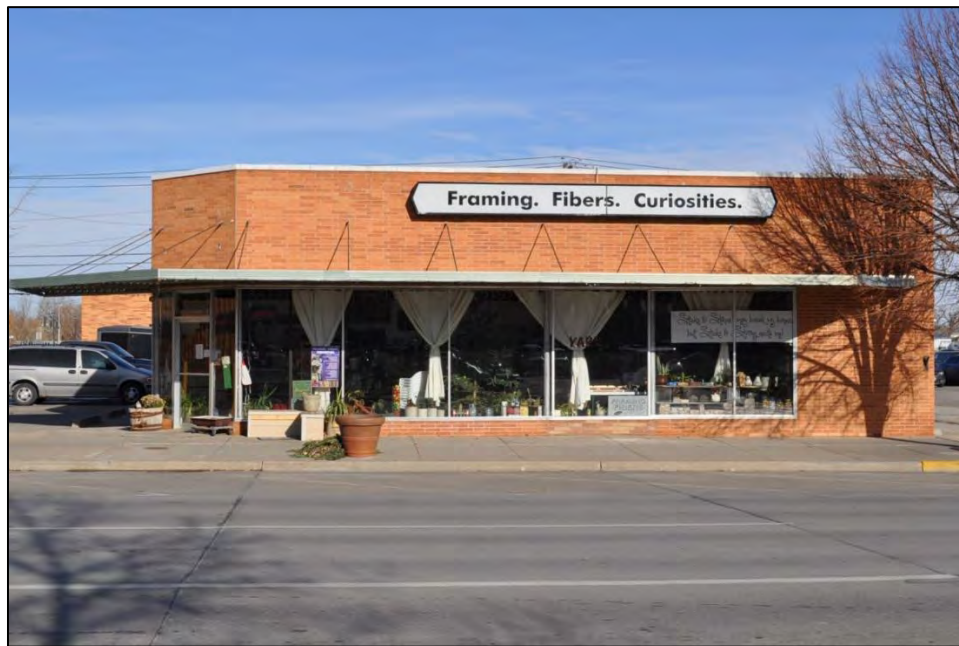
Figure 45. 230 Main St., facing north. B. Moloney 12/2/2016.

It is a one story rectangular commercial building oriented lengthwise generally north south with a garage ell on its northern extent. Building is concrete block faced in bright orange brick on the south and west elevations set in a running or stretcher bond. Brick possibly originated from the Black Hills Clay Products Plant in Belle Fouche. Parapet wall extends exterior wall around south most portion of building around the storefront. Primary entrance to storefront is located on clipped southwest corner of main body of building. Plate glass display windows in aluminum frames line south wall and wrap around clipped corner. Cabled marquee awning extends over entrance and full length of windows. Entry door is plate glass with glass window surrounds. Two secondary entry doors on west elevation north of main entrance, two twinned double-hung, one over one windows with concrete sills flank north most door; all replacements. Security door with transom and twinned double hung, one over one window on south elevation of ell. Service door on west elevation of ell.

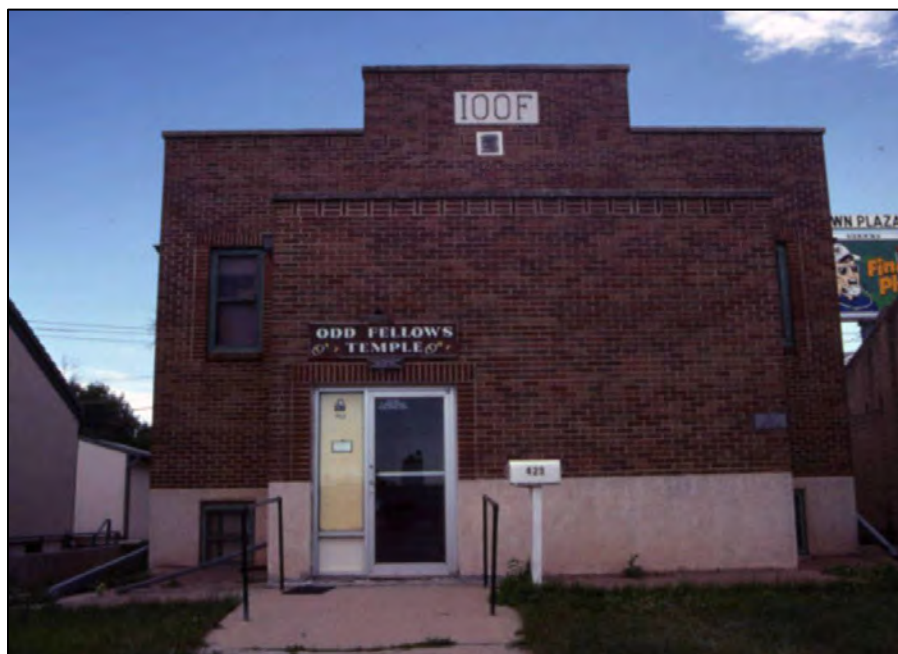
Figure 47. View of IOOF Hall front elevation before addition. (Rapid City 1995).
