Case No. 16UR004

**TKRS PROPERTIES**  
 11 NEW YORK STREET  
 RAPID CITY, SD

Revision / Date  
 Sheet Name  
**OVERALL FENCE LAYOUT**  
 Sheet Number  
**1 of 3**

On January 29, 2016, Senior Officer Ron Terviel and I (Senior Officer Robin Black) had the opportunity to do a Crime Prevention Through Environmental Design (CPTED) Inspection at Prairie Market and Time Square Plaza, 11 New York St. Prairie Market is a grocery store.

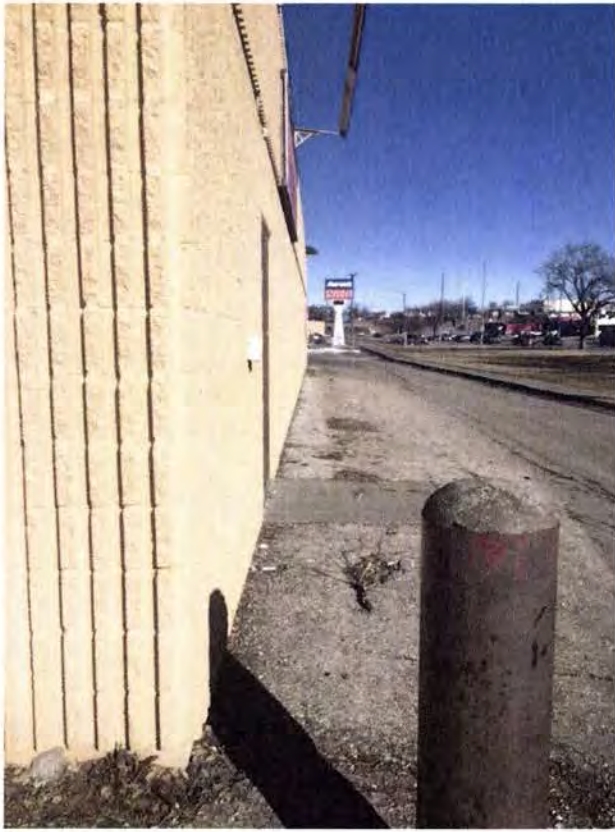
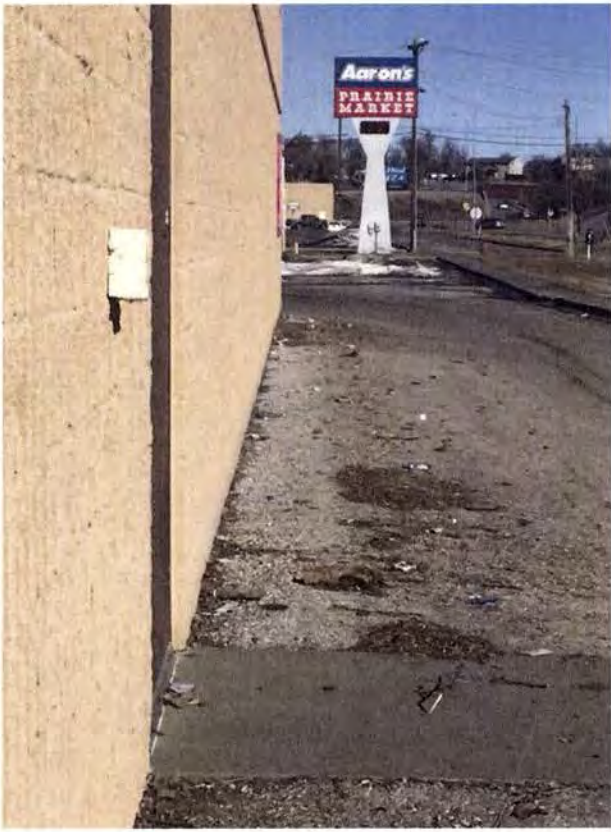
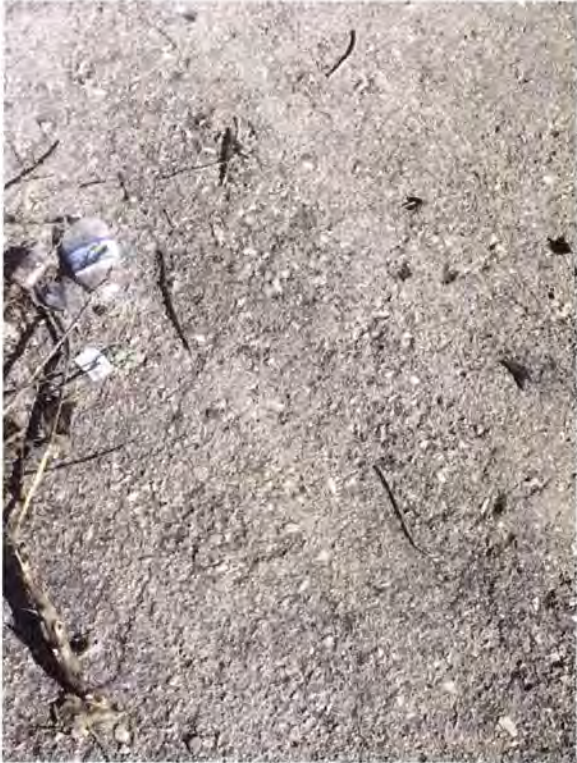
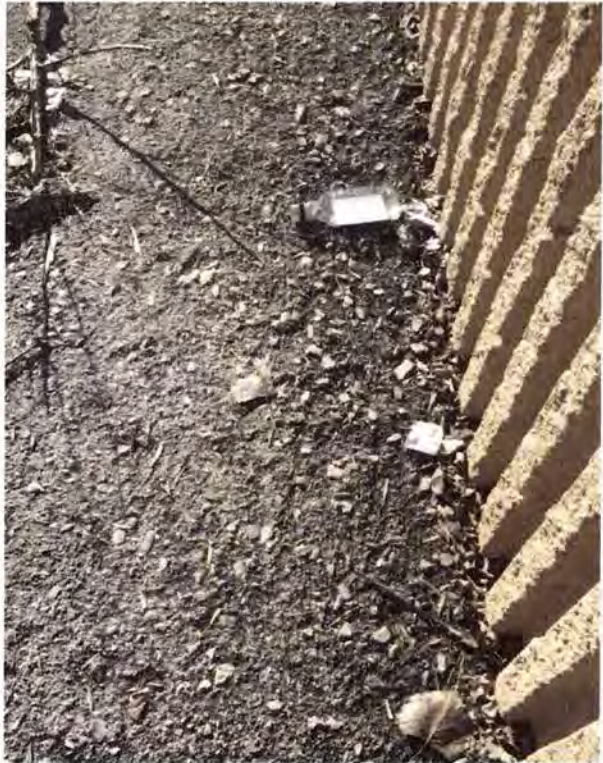
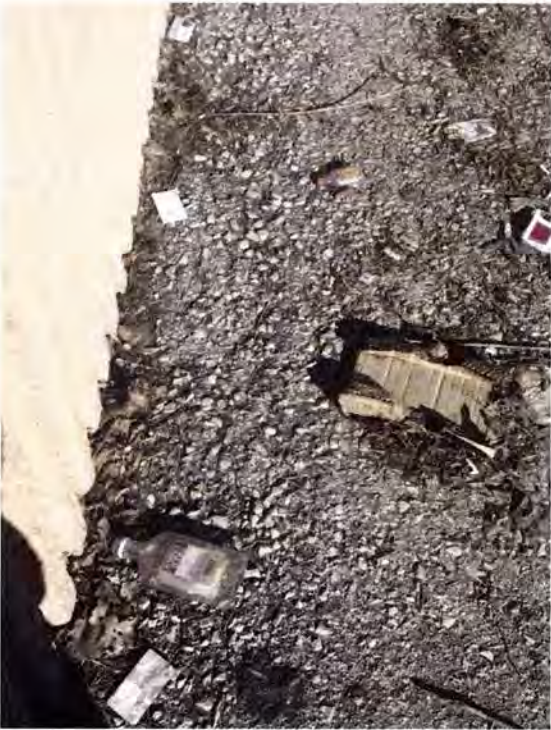
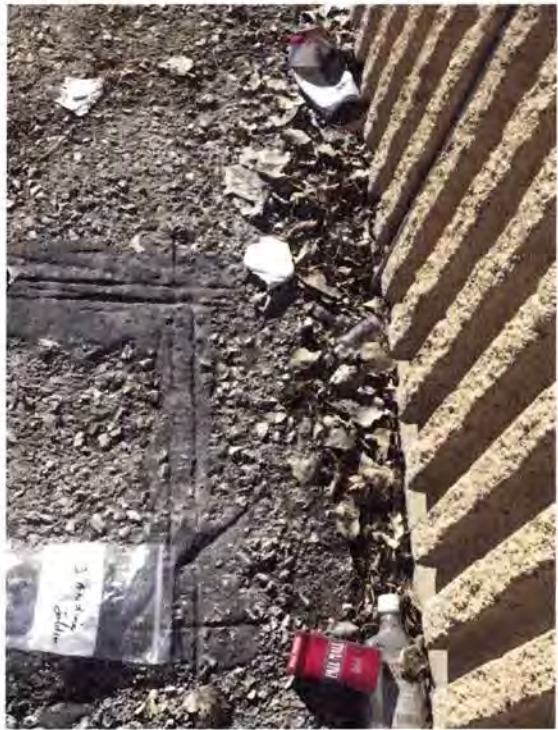
We went to the east side of the building, we observed the roadway leading to the south side (back) of the building had trash up against the building and also broken glass on the road. There was a door on the east side of the building, which was not accessible from the outside. There was a light above a sign on the east side of the building. I am not sure how much the light illuminates the outside of the building at night. This area had several empty alcohol containers and debris along the roadway and the building. There was also broken glass on the roadway.

The pictures below are of the east side also.

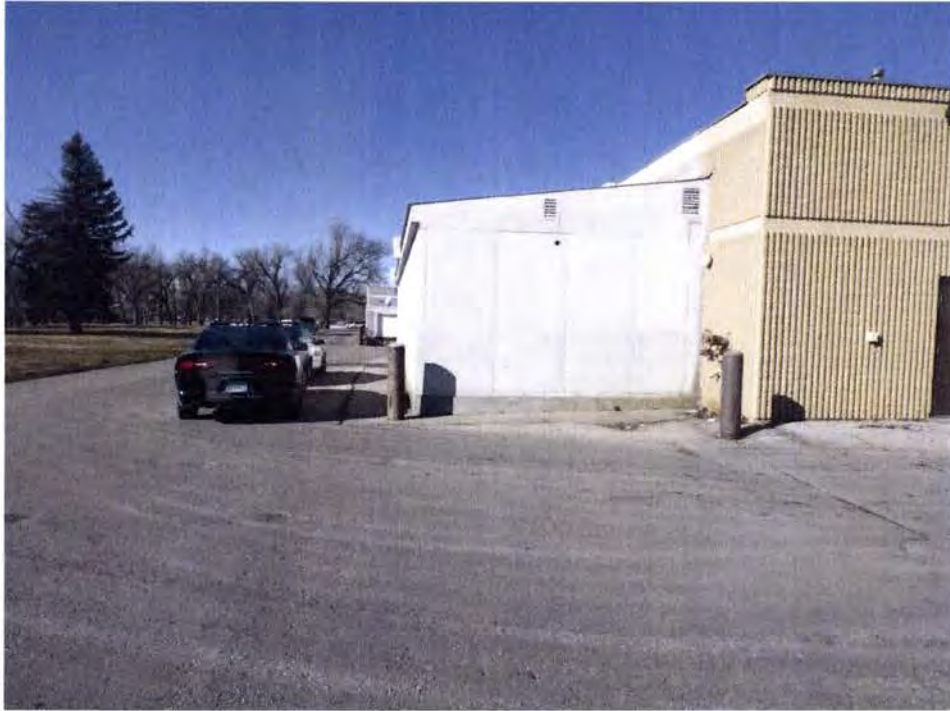
We went to south side (back) of the building and there was debris there also. This is the delivery area where the trucks come in the back doors. Also employees use this area to smoke in and the trash container is in the back of the building.

This is looking to the west from the southeast corner of the store.

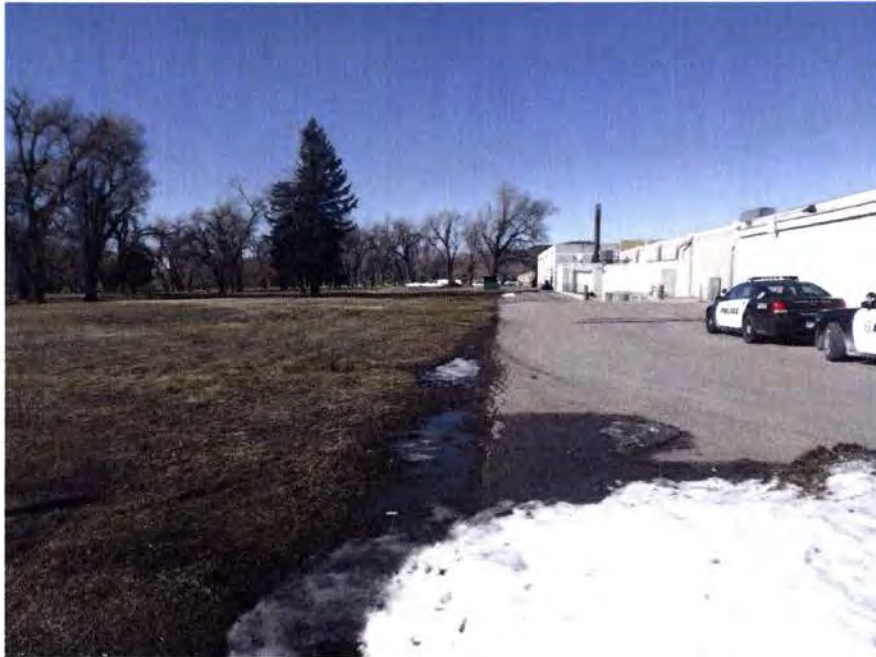
This is looking to the west from the southeast corner of the store. The end of pavement is the end of Prairie Market's property line.

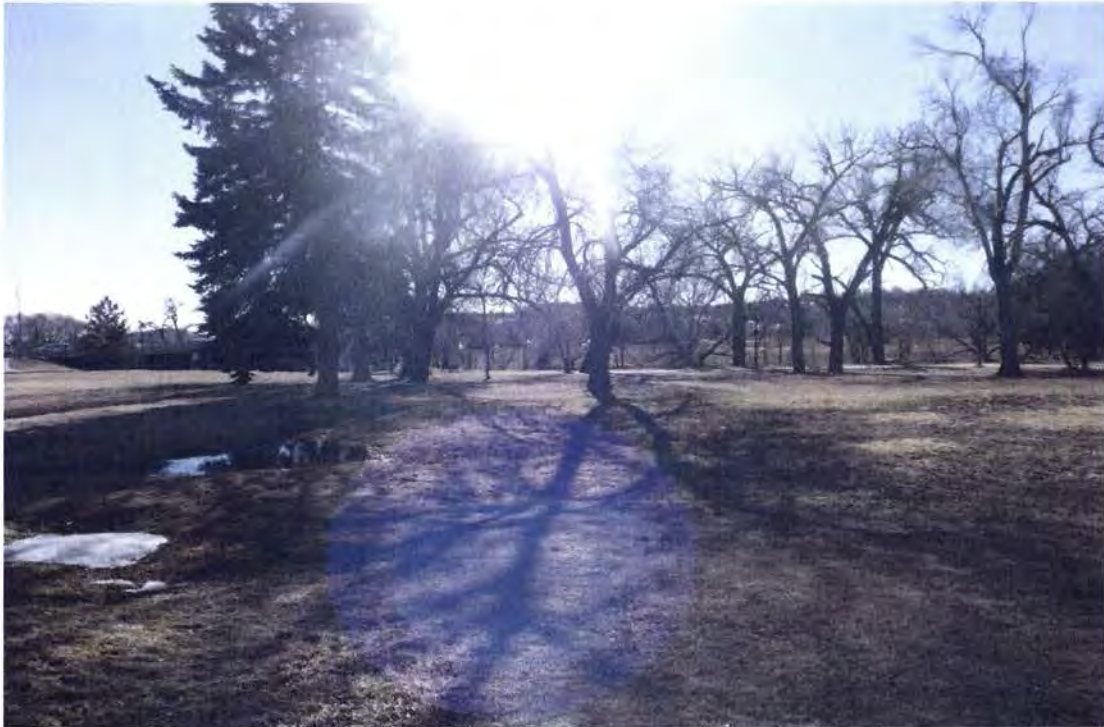
This is the New York Street Park/Dog Park area. This is also used by many people to walk their dogs off leash. The park is located directly behind the unit and one hundred block of New York Street.

The park closes at 2200 hours and that helps with the calls for service in this area after 2200 hours. There is also a lighted bike path with the solar lights installed.

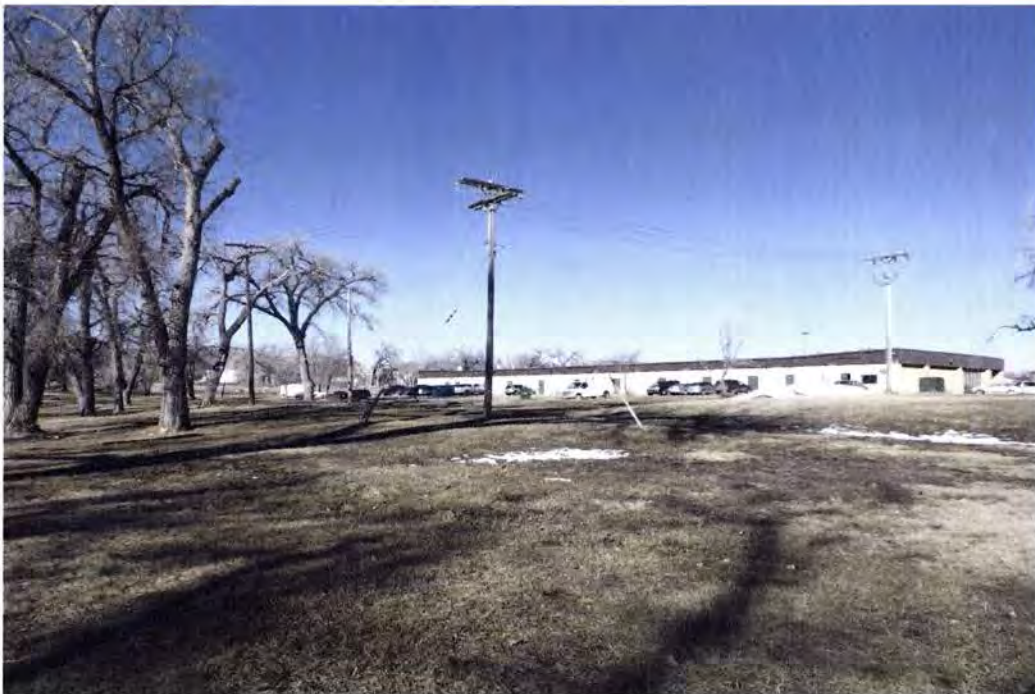
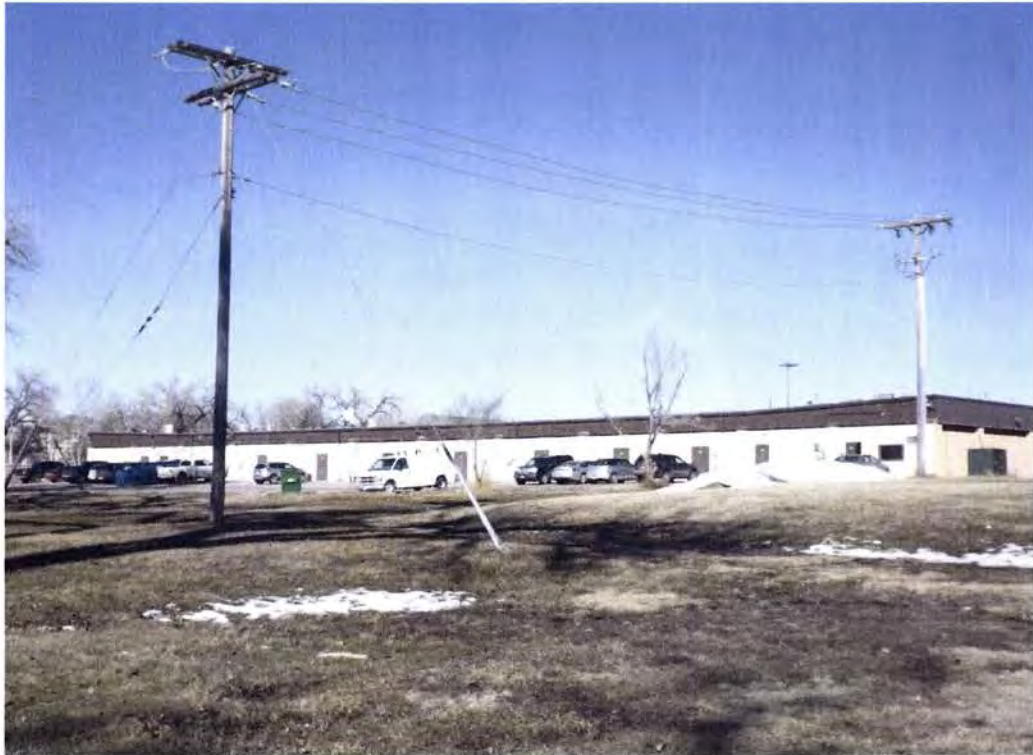
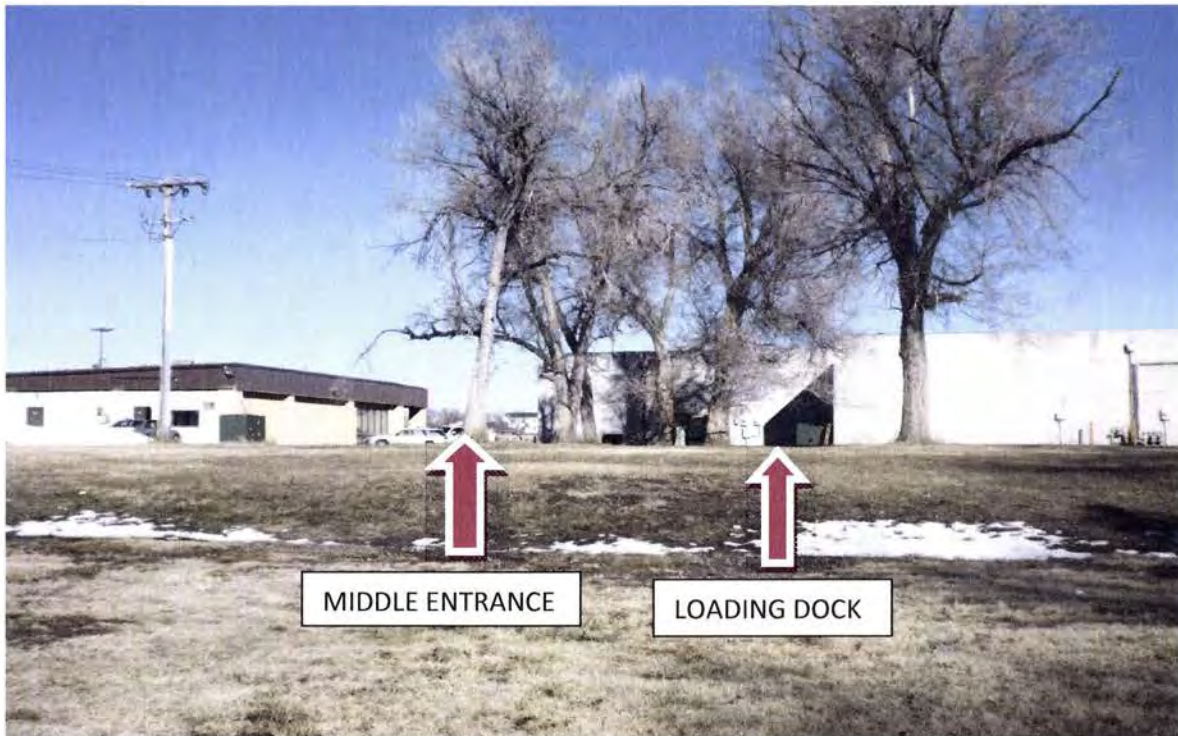
The next area we would like to talk about is to the west of Prairie Market and on the south side of the unit block and hundred block of New York Street. It also leads to the west side of the property.

The access area for the trucks to drive through is in the middle of the unit and one hundred block of New York Street. This area separates the two buildings on the south side of the parking lot. There is also parking allowed in this area.

It would stop unwanted foot traffic to and from the area in the back. This is also a high area for intoxicated subjects and alcohol violations. The dumpster for the 100 block is kept in the back of the building, however would not be a problem for garbage trucks to enter and exit the property.

With the fencing going along side of the south side of the property, it would cause no issues with parking or delivery trucks.

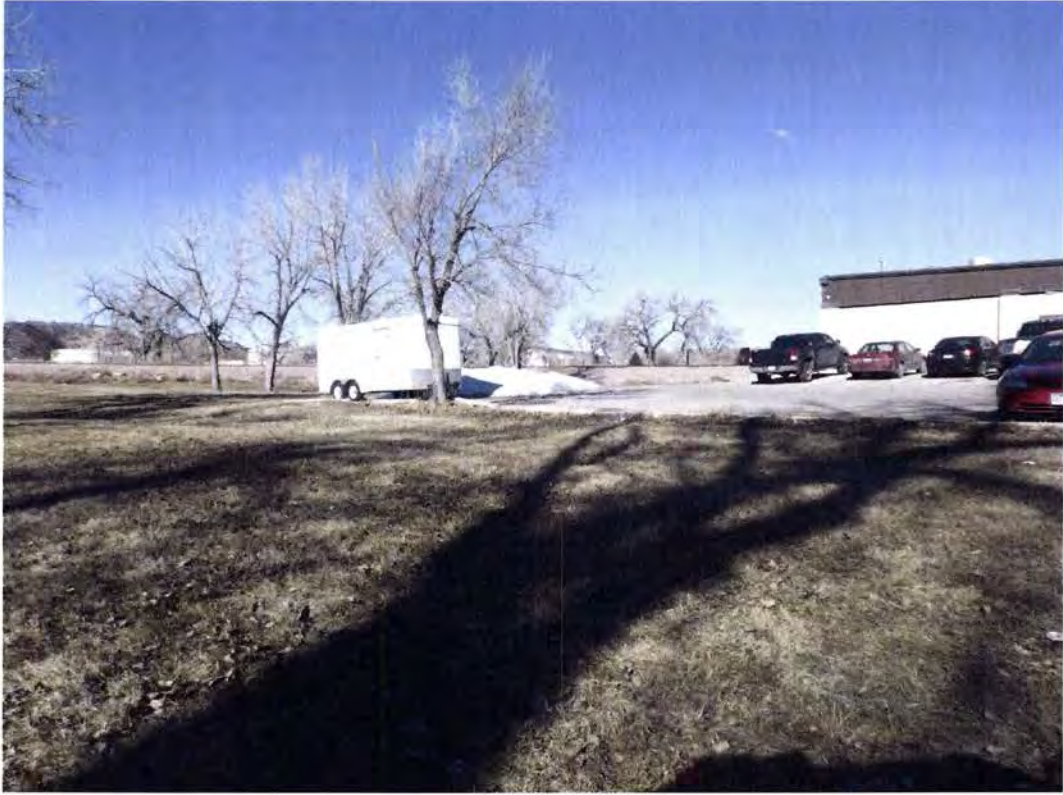
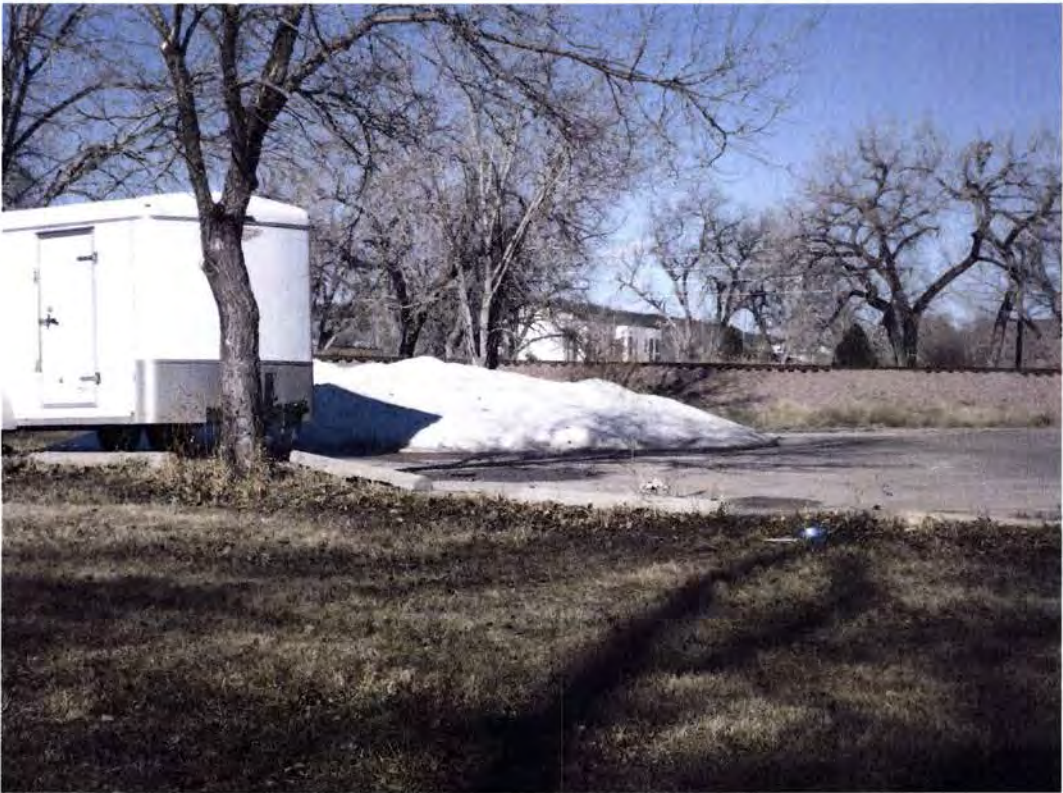
This picture shows the property line and the back (South) parking lot of the 100 block of New York Street. One thing should be noticed concerning this picture. The white van in the picture has been parked for approximately a year. It has flat tires and the back windows are completely broken in. As we know, this causes people to damage the property more often and the van has been burglarized several times. Having a fence in this area would help deter people from being in the parking lot during and after hours. If people don't have an easy way off property, they are less likely to do damage or commit criminal activity.

In the New York Street Park behind this building, are some of our highest calls for service. We had calls for service to include but not limited to: intoxicated subjects, alcohol violations, assaults, shots fired, weapon calls, and passed out subjects. This area is very active in the summertime with calls for service.

This is the southwest corner of the property. This area is also used as a snow removal area and the snow goes beyond the property line. Also there is a trailer that is stored in this area, however it is secured.

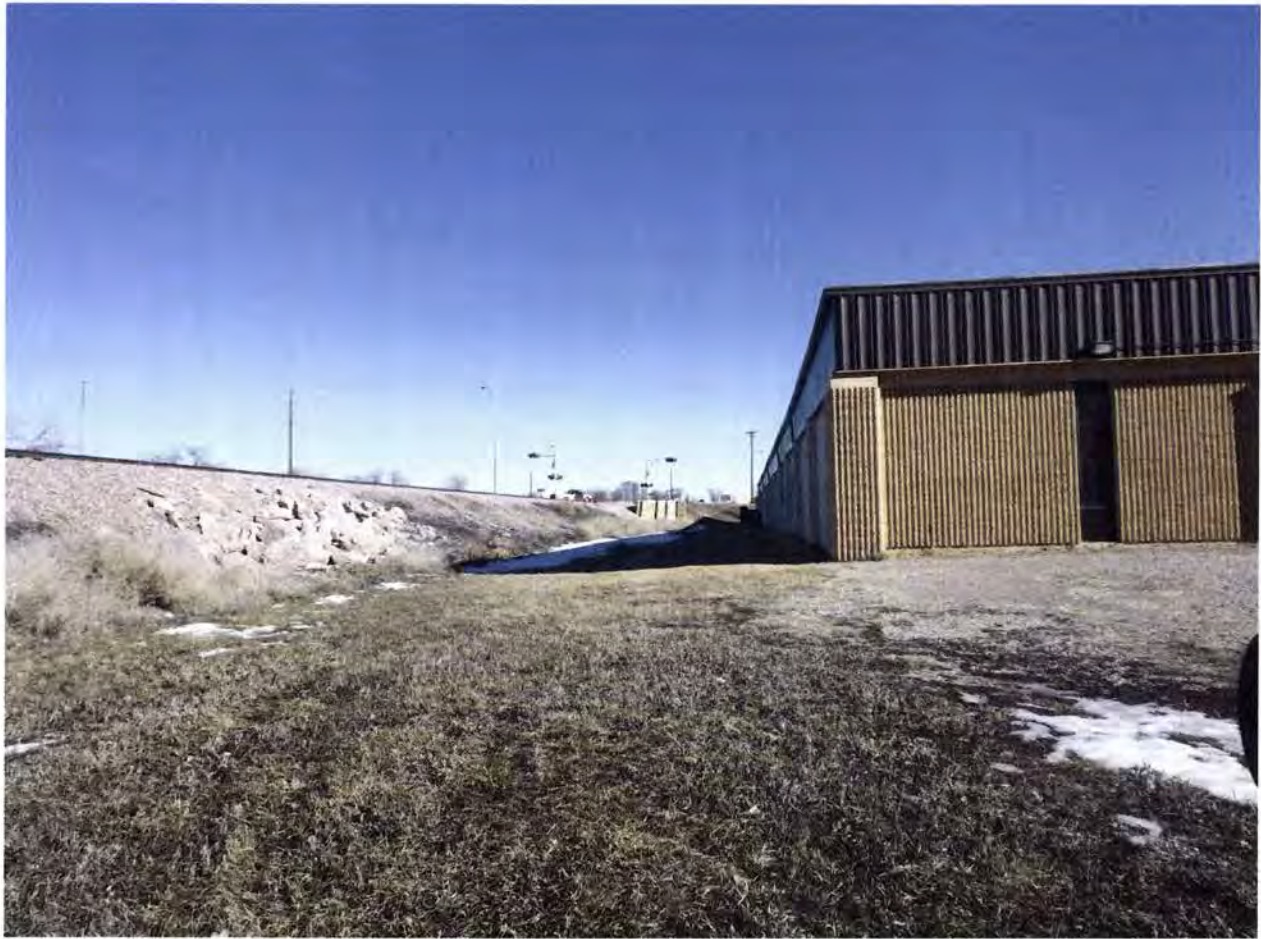
This is the northwest side of the property. This area is a high volume call area because of intoxicated or passed out subjects. We also have high calls for service in this area for alcohol violations. Also it is not visible from the road and a good hiding spot for criminal activity. We have also experienced some "tagging" and vandalism on the back of the building.
